DEPARTMENT OF TRANSPORTATION

Contract #: 04-0120F4Cty: SF/ALA Rte: 80 PM: 13.2/13.9File #: 99.28**WELDING INSPECTION REPORT****Resident Engineer:** Siegenthaler, Peter**Address:** 333 Burma Road**City:** Oakland, CA 94607**Report No:** WIR-018580**Date Inspected:** 14-Dec-2010**Project Name:** SAS Superstructure**OSM Arrival Time:** 700**Prime Contractor:** American Bridge/Fluor Enterprises, a JV**OSM Departure Time:** 1900**Contractor:** Zhenhua Port Machinery Company, Ltd (ZPMC)**Location:** Shanghai, China**CWI Name:** Li Yang and Zhu Zhong Hai**CWI Present:** Yes No**Inspected CWI report:** Yes No N/A**Rod Oven in Use:** Yes No N/A**Electrode to specification:** Yes No N/A**Weld Procedures Followed:** Yes No N/A**Qualified Welders:** Yes No N/A**Verified Joint Fit-up:** Yes No N/A**Approved Drawings:** Yes No N/A**Approved WPS:** Yes No N/A**Delayed / Cancelled:** Yes No N/A**Bridge No:** 34-0006**Component:** OBG Trial Assembly**Summary of Items Observed:**

WELDING INSPECTION REPORT

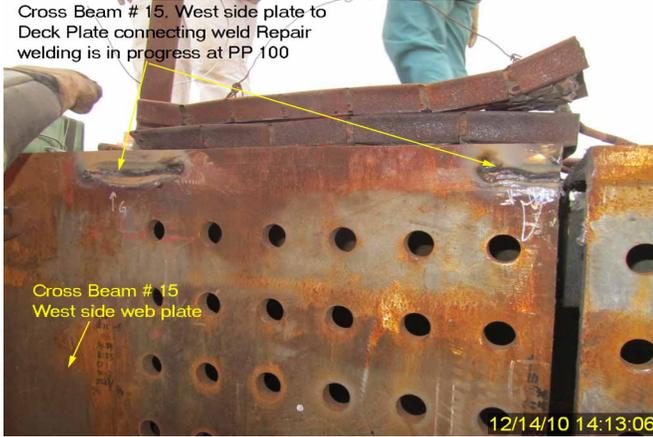
This QA Inspector observed the repair welding by Shielded Metal Arc Welding (SMAW) process on a Complete Joint Penetration (CJP) groove weld. The Weld joint was designated as CB202A-015-001. The welder identification was 050289 and was observed welding in the 2G (Horizontal) position using approved Welding Procedure Specification WPS-345-SMAW-2G(2F)-FCM-Repair-1. The piece mark was identified as the Cross Beam #15, East side Web plate to Deck Plate at PP 100. ZPMC personnel performing repair welding in accordance with Welding Repair Report B-WR18800.

Cross Beam # 15. West side plate to Deck Plate connecting weld Repair welding is in progress at PP 100

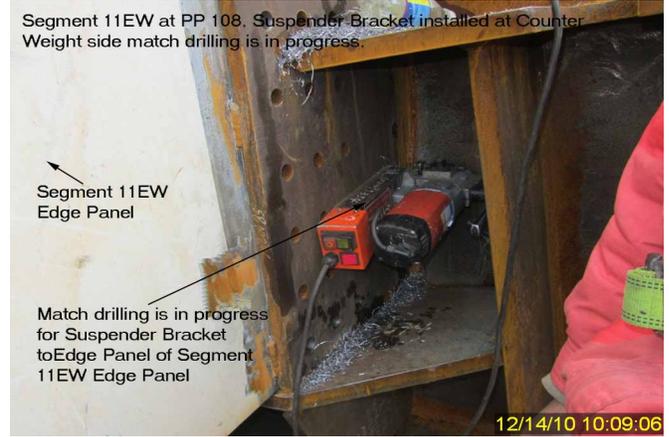
This QA Inspector observed match drilling is in progress for the Suspender Bracket plate to the Edge panel installed at PP 108, Counter Weight side for Segment 11EE.

Segment 11EW at PP 108. Suspender Bracket installed at Counter Weight side match drilling is in progress.
