DEPARTMENT OF TRANSPORTATION

Contract #: 04-0120F4Cty: SF/ALA Rte: 80 PM: 13.2/13.9File #: 1.28**WELDING INSPECTION REPORT****Resident Engineer:** Siegenthaler, Peter**Address:** 333 Burma Road**City:** Oakland, CA 94607**Report No:** WIR-018587**Date Inspected:** 09-Dec-2010**Project Name:** SAS Superstructure**OSM Arrival Time:** 1000**Prime Contractor:** American Bridge/Fluor Enterprises, a JV**OSM Departure Time:** 1830**Contractor:** American Bridge/Fluor Enterprises, a JV**Location:** Jobsite**CWI Name:** See below**CWI Present:** Yes No**Inspected CWI report:** Yes No N/A**Rod Oven in Use:** Yes No N/A**Electrode to specification:** Yes No N/A**Weld Procedures Followed:** Yes No N/A**Qualified Welders:** Yes No N/A**Verified Joint Fit-up:** Yes No N/A**Approved Drawings:** Yes No N/A**Approved WPS:** Yes No N/A**Delayed / Cancelled:** Yes No N/A**Bridge No:** 34-0006**Component:** SAS OBG**Summary of Items Observed:**

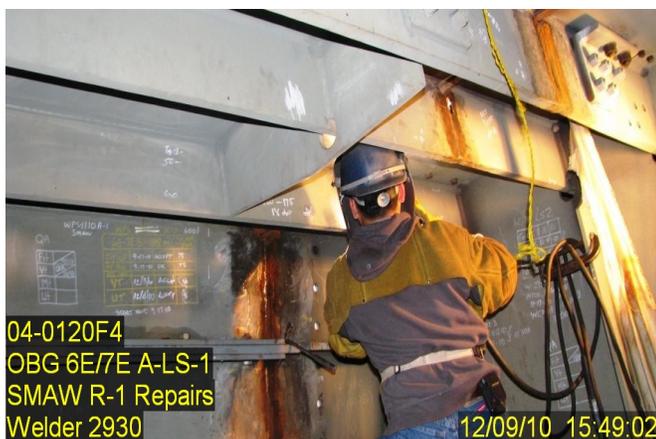
4). Longitudinal Stiffeners (A-LS) Splice at OBG Field Splice 6E/7E (SMAW R-1 Repairs)

The QAI periodically observed AB/F approved welder Hua Qiang Hwang (ID 2930) performing R-1 repair welding per the Shielded Metal Arc Welding (SMAW) process in the 3G (vertical) position on A-LS-1 and A-LS-2 at OBG Field Splice 6E/7E. See photo below. QC Inspector Fred Von Hoff was present to monitor the progress and verify that the welding parameters were within the limits established by the approved welding Procedure Specification (WPS) identified as ABF-WPS-D1.5-1002 Repair. The welding was completed of two excavations in the North face of A-LS-1 and one excavation in the North face of A-LS-2 and the QAI observed that the work at this location appeared to be in general compliance with contract documents. The excavated areas were at the following Y locations with the following dimensions:

A-LS-1 Excavation #1 - Y = 20mm, Length = 50mm, Width = 22mm and Depth = 17mm.

A-LS-1 Excavation #2 - Y = 120mm, Length = 55mm, Width = 20mm and Depth = 18mm.

A-LS-2 Excavation #1 - Y = 5mm, Length = 60mm, Width = 22mm and Depth = 18mm.

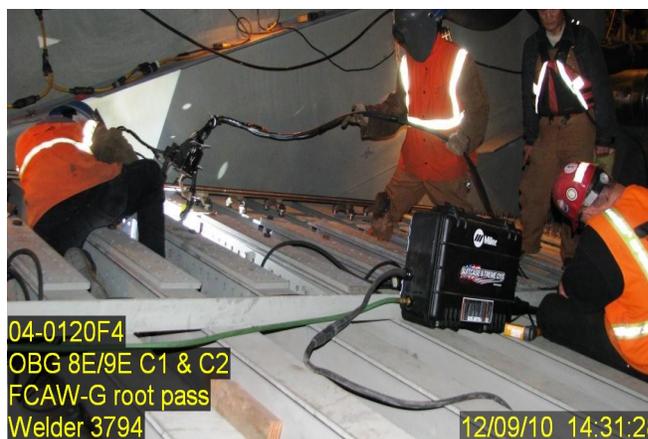
5). OBG Field Splice 8E/9E Weld ID: C1 & C2, Face A (FCAW-G)

welder Jin Quan Huang (ID 9340) performing welding of OBG Field Splice 8E/9E Weld ID: C1 & C2 per the Flux Cored Arc Welding (FCAW-G) process in the 3G (vertical) position. See photo below. The QAI observed QC Inspector John Paglieri was present to monitor the progress and verify that the welding parameters were within the limits established by the approved welding Procedure Specification (WPS) identified as ABF-WPS-D1. 5-3042B-1. The welding of root and fill passes was in process and the QAI observed that the work appeared to be in general compliance with contract documents.
