DEPARTMENT OF TRANSPORTATION

Contract #: 04-0120F4Cty: SF/ALA Rte: 80 PM: 13.2/13.9File #: 1.28**WELDING INSPECTION REPORT****Resident Engineer:** Siegenthaler, Peter**Address:** 333 Burma Road**City:** Oakland, CA 94607**Report No:** WIR-018590**Date Inspected:** 09-Dec-2010**Project Name:** SAS Superstructure**OSM Arrival Time:** 1000**Prime Contractor:** American Bridge/Fluor Enterprises, a JV**OSM Departure Time:** 1830**Contractor:** American Bridge/Fluor Enterprises, a JV**Location:** Job Site

Caltrans Office of Structural Material (OSM) Quality Assurance Inspector (QAI) Joselito Lizardo was present at the Self Anchored Suspension (SAS) job site as requested to perform observations on the welding of components for the San Francisco Oakland Bay Bridge (SFOBB) Project.

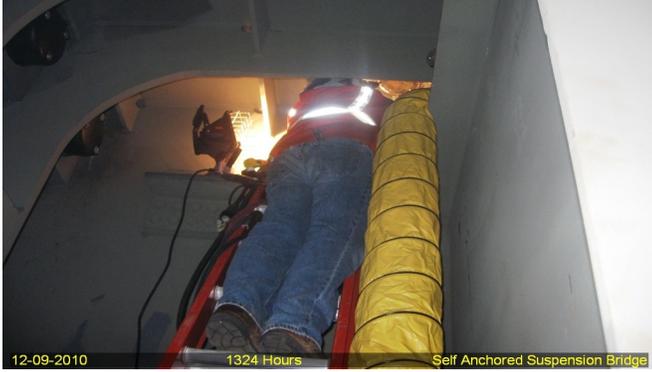
At OBG 1W-PP8.5-W4-#3 lifting lug access holes infill plate inside, QA randomly observed ABF welder Mike Jimenez perform Shielded Metal Arc Welding (SMAW) back welding cover pass on the infill plate to top deck plate butt joint. The welder was noted welding in 4G (overhead) position using 1/8" diameter E7018H4R electrode implementing Caltrans approved Welding Procedure Specification (WPS) ABF-WPS-D15-1110B. During welding, ABF QC Mike Johnson was noted monitoring the welder's welding parameters. At the end of the shift, cover pass welding on the location mentioned above was completed. After the welding completion, ABF QC Mike Johnson has requested this QA to verify the flush grinding/grinding cut orientation and smooth finish of the bottom side welding which this QA has concurred.

At OBG 1W-PP8.5-W4-#3 lifting lug access hole infill plate to top deck plate inside, ABF welder Mike Jimenez was observed 4G Shielded Metal Arc Welding (SMAW) back welding fill pass on the butt joint.

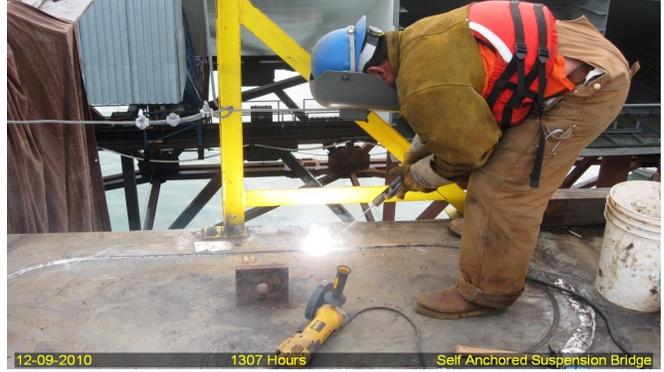
At OBG 6W-PP46.5-W5-S access hole infill plate to top deck plate outside, QA randomly observed ABF/JV qualified welder Jorge Lopez perform Complete Joint Penetration (CJP) groove fill pass welding. The welder was observed welding in the 1G (flat) position utilizing SMAW with 1/8" diameter E7018H4R electrode implementing Caltrans approved welding procedure ABF-WPS-D15-1010 Revision 1. The joint being welded has a double V-groove butt joint. ABF Quality Control (QC) William Sherwood was noted monitoring the welding parameters of the welder. At the end of the shift, fill pass welding of the butt joint at location mentioned above was still continuing and should remain tomorrow.

At OBG 6W PP46.5-W5-S deck access hole infill plate to top deck plate outside, ABF welder Jorge Lopez was observed Shielded Metal Arc Welding (SMAW) welding fill pass on the butt joint.

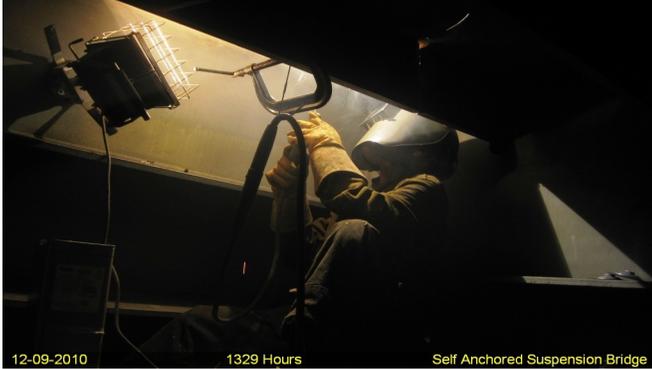
At OBG 1W-PP10.5-W2-TS top deck ventilation access hole inside, QA noted ABF/JV qualified welder Jin Pei Wang ID #2930 has completely welded the CJP transverse stiffener splice butt joint. After completing the transverse stiffener butt joint, the welder has started welding the root pass of the deck access hole infill plate to top deck plate at the same access hole. The welder was observed manually welding in the 4G (overhead) position utilizing a SMAW with 1/8" diameter E7018H4R electrode and implementing Caltrans approved WPS ABF-WPS-D15-1010 Revision 1. The joint being welded has a double V-groove butt joint. During welding, ABF Quality Control (QC) William Sherwood was also noted monitoring the welding parameters of the welder. During the shift, SMAW root pass welding underneath the butt joint was still continuing and remain tomorrow.

At OBG 1W-PP10.5-W2-N deck access hole infill plate to top deck plate inside, ABF welder Jin Pei Wang was observed 4G Shielded Metal Arc Welding (SMAW) welding root pass on the butt joint.
