DEPARTMENT OF TRANSPORTATION

Quality Assurance and Source Inspection

Contract #: 04-0120F4Cty: SF/ALA Rte: 80 PM: 13.2/13.9File #: 69.28**WELDING INSPECTION REPORT****Resident Engineer:** Siegenthaler, Peter**Address:** 333 Burma Road**City:** Oakland, CA 94607**Report No:** WIR-018609**Date Inspected:** 15-Dec-2010**Project Name:** SAS Superstructure**OSM Arrival Time:** 700**Prime Contractor:** American Bridge/Fluor Enterprises, a JV**OSM Departure Time:** 1900**Contractor:** Zhenhua Port Machinery Company, Ltd (ZPMC), Changxing Island **Location:** Shanghai, China**CWI Name:** Li Yang**CWI Present:** Yes No**Inspected CWI report:** Yes No N/A**Rod Oven in Use:** Yes No N/A**Electrode to specification:** Yes No N/A**Weld Procedures Followed:** Yes No N/A**Qualified Welders:** Yes No N/A**Verified Joint Fit-up:** Yes No N/A**Approved Drawings:** Yes No N/A**Approved WPS:** Yes No N/A**Delayed / Cancelled:** Yes No N/A**Bridge No:** 34-0006**Component:** OBG Segment**Summary of Items Observed:**

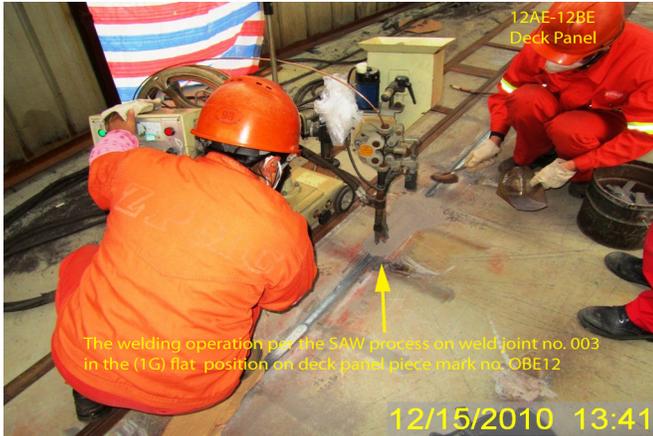
The QA Inspector observed the welding operation per the SAW process on weld joint no. 003 in the (1G) flat position on deck panel piece mark no. OBE12. The location was the transverse splice weld joining segment 12AE and 12BE at work point E5 to E2. The welder ID was 040460. The ZPMC CWI was identified as Li Yang. The welding variables recorded by QC appeared to comply with the WPS-B-T-223(2)1T-ESAB. For additional information please reference the pictures below:
