DEPARTMENT OF TRANSPORTATION

Contract #: 04-0120F4Cty: SF/ALA Rte: 80 PM: 13.2/13.9File #: 74.28**WELDING INSPECTION REPORT****Resident Engineer:** Siegenthaler, Peter**Address:** 333 Burma Road**City:** Oakland, CA 94607**Report No:** WIR-018637**Date Inspected:** 13-Dec-2010**Project Name:** SAS Superstructure**OSM Arrival Time:** 730**Prime Contractor:** American Bridge/Fluor Enterprises, a JV**OSM Departure Time:** 1730**Contractor:** Goodwin Steel, UK**Location:** Trentham, UK

Bridge No: 34-0006**Component:** Cable Band**Summary of Items Observed:**

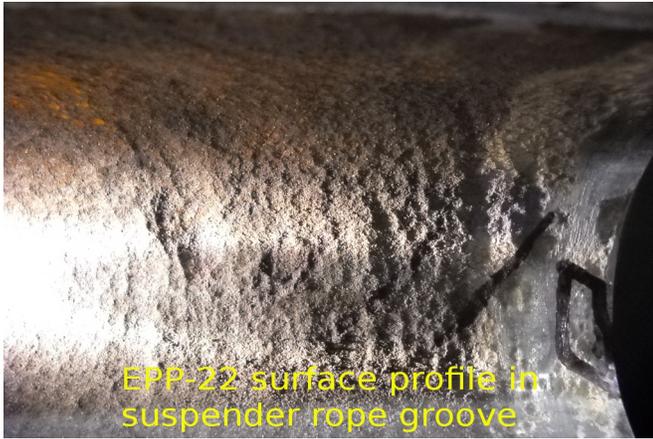
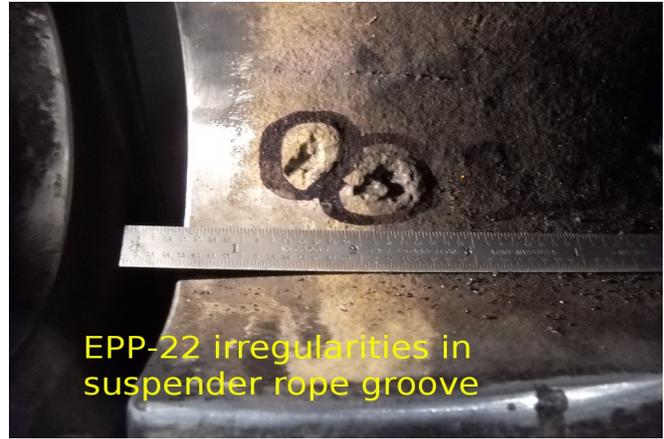
The QA Inspector was requested to observe measurement of the length of the suspender rope grooves on the cable band for panel point 22 east bound. The QA Inspector noted the following:

- ~The surface profile of the suspender rope grooves does not meet the requirement of ANSI 500.
- ~discontinuities in the suspender rope groove were noted.
- ~An arc strike was noted on an as cast surface.

This was pointed out to Mr. A. Cashmore who marked the casting for additional dressing. Digital photographs are included in this report.
