**DEPARTMENT OF TRANSPORTATION**

Contract #: 04-0120F4Cty: SF/ALA Rte: 80 PM: 13.2/13.9File #: 1.28**WELDING INSPECTION REPORT****Resident Engineer:** Siegenthaler, Peter**Address:** 333 Burma Road**City:** Oakland, CA 94607**Report No:** WIR-018638**Date Inspected:** 15-Dec-2010**Project Name:** SAS Superstructure**OSM Arrival Time:** 630**Prime Contractor:** American Bridge/Fluor Enterprises, a JV**OSM Departure Time:** 1500**Contractor:** American Bridge/Fluor Enterprises, a JV**Location:** Job Site**CWI Name:** See Below**CWI Present:** Yes No**Inspected CWI report:** Yes No N/A**Rod Oven in Use:** Yes No N/A**Electrode to specification:** Yes No N/A**Weld Procedures Followed:** Yes No N/A**Qualified Welders:** Yes No N/A**Verified Joint Fit-up:** Yes No N/A**Approved Drawings:** Yes No N/A**Approved WPS:** Yes No N/A**Delayed / Cancelled:** Yes No N/A**Bridge No:** 34-0006**Component:** Orthotropic Box Girders**Summary of Items Observed:**

## WELDING INSPECTION REPORT

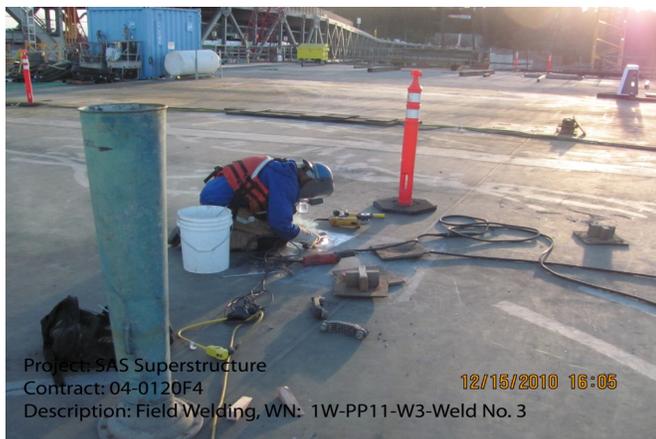
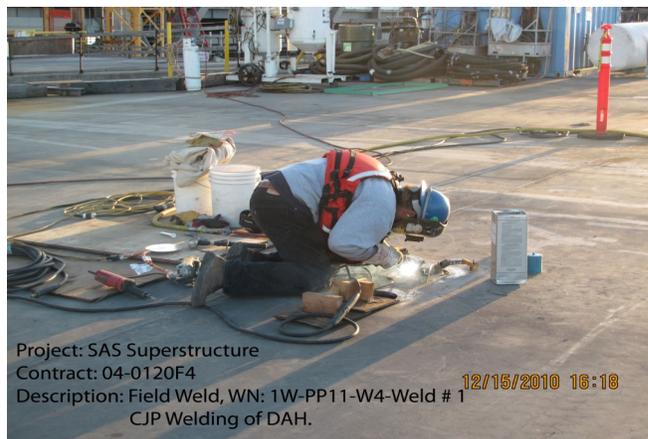
The digital photographs on page 4 of this report illustrate the work observed during this scheduled shift.
