Contract #: 04-0120F4Cty: SF/Ala Rte: 80 PM: 13.2/13.9File #: 69.28**WELDING INSPECTION REPORT****Resident Engineer:** Siegenthaler, Peter**Address:** 333 Burma Road**City:** Oakland, CA 94607**Report No:** WIR-018677**Date Inspected:** 07-Nov-2010**Project Name:** SAS Superstructure**OSM Arrival Time:** 1900**Prime Contractor:** American Bridge/Fluor Enterprises, a JV**OSM Departure Time:** 700**Contractor:** Zhenhua Port Machinery Company, Ltd (ZPMC), Changxing Island **Location:** Shanghai, China**CWI Name:** See below**CWI Present:** Yes No**Inspected CWI report:** Yes No N/A**Rod Oven in Use:** Yes No N/A**Electrode to specification:** Yes No N/A**Weld Procedures Followed:** Yes No N/A**Qualified Welders:** Yes No N/A**Verified Joint Fit-up:** Yes No N/A**Approved Drawings:** Yes No N/A**Approved WPS:** Yes No N/A**Delayed / Cancelled:** Yes No N/A**Bridge No:** 34-0006**Component:** Tower and OBG Components**Summary of Items Observed:**

OBG Trial Assembly Area

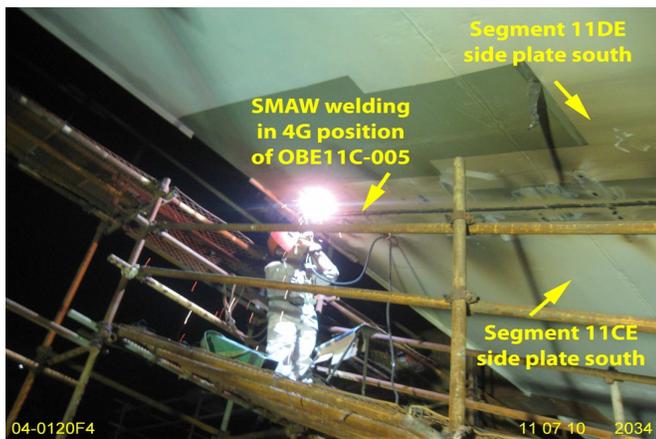
SMAW repair welding of base metal located outside PCMK OBG 11CE/11DE, transverse weld joint OBE11C-005 area where temporary alignment plates had been previously removed, and also SMAW of the same weld joint, side plate to side plate, south (bikepath) side. See photo below. Welder was identified as 050289. QC was identified as ZPMC CWI Liu Hua Jie (QC1). Welding variables recorded by QC1 appeared to comply with WPS-345-SMAW-4G(4F)-FCM-repair-1 as displayed on ZPMC Weld Repair Report B-CWR1842 presented to this QA Inspector and verbally identified by QCA1 and WPS-B-P-2214-B-U2-FCM-1.
