DEPARTMENT OF TRANSPORTATION

Quality Assurance and Source Inspection

Contract #: 04-0120F4Cty: SF/Ala Rte: 80 PM: 13.2/13.9File #: 69.28**WELDING INSPECTION REPORT****Resident Engineer:** Siegenthaler, Peter**Address:** 333 Burma Road**City:** Oakland, CA 94607**Report No:** WIR-018684**Date Inspected:** 17-Nov-2010**Project Name:** SAS Superstructure**OSM Arrival Time:** 1900**Prime Contractor:** American Bridge/Fluor Enterprises, a JV**OSM Departure Time:** 700**Contractor:** Zhenhua Port Machinery Company, Ltd (ZPMC), Changxing Island **Location:** Shanghai, China**CWI Name:** See below**CWI Present:** Yes No**Inspected CWI report:** Yes No N/A**Rod Oven in Use:** Yes No N/A**Electrode to specification:** Yes No N/A**Weld Procedures Followed:** Yes No N/A**Qualified Welders:** Yes No N/A**Verified Joint Fit-up:** Yes No N/A**Approved Drawings:** Yes No N/A**Approved WPS:** Yes No N/A**Delayed / Cancelled:** Yes No N/A**Bridge No:** 34-0006**Component:** Tower and OBG Components**Summary of Items Observed:**

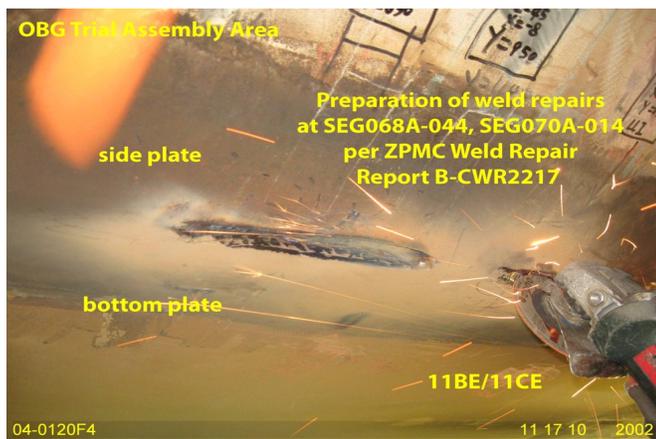
SMAW repair welding of weld joints SEG068A-044, SEG070A-014 in multiple locations outside PCMK OBG 11BE/11CE, holdback welds, side plate to bottom plate, south (bikepath) side. See photo below showing ZPMC worker preparing one of the repairs by grinding. Welders were identified respectively as 040265, 044515. QC was identified as ZPMC CWI Shi Lei (QC1). Welding variables recorded by QC1 appeared to comply with WPS-345-SMAW-4G(4F)-FCM-1 as displayed on ZPMC Weld Repair Report B-CWR2217 presented to this QA Inspector and verbally identified by QC1. QC1 informed this QA Inspector that this welding was being performed to correct indications as a result of ZPMC ultrasonic testing (UT). ZPMC Weld Repair Report B-CWR2217 referred to a ZPMC NDT Report as NA, however ZPMC NDT Report UT-11E-0048R3(pre 48) was attached to the ZPMC Weld Repair Report.
