DEPARTMENT OF TRANSPORTATION

Quality Assurance and Source Inspection

Contract #: 04-0120F4Cty: SF/Ala Rte: 80 PM: 13.2/13.9File #: 69.28**WELDING INSPECTION REPORT****Resident Engineer:** Siegenthaler, Peter**Address:** 333 Burma Road**City:** Oakland, CA 94607**Report No:** WIR-018692**Date Inspected:** 27-Nov-2010**Project Name:** SAS Superstructure**OSM Arrival Time:** 1900**Prime Contractor:** American Bridge/Fluor Enterprises, a JV**OSM Departure Time:** 700**Contractor:** Zhenhua Port Machinery Company, Ltd (ZPMC), Changxing Island **Location:** Shanghai, China**CWI Name:** See below**CWI Present:** Yes No**Inspected CWI report:** Yes No N/A**Rod Oven in Use:** Yes No N/A**Electrode to specification:** Yes No N/A**Weld Procedures Followed:** Yes No N/A**Qualified Welders:** Yes No N/A**Verified Joint Fit-up:** Yes No N/A**Approved Drawings:** Yes No N/A**Approved WPS:** Yes No N/A**Delayed / Cancelled:** Yes No N/A**Bridge No:** 34-0006**Component:** Tower and OBG Components**Summary of Items Observed:**

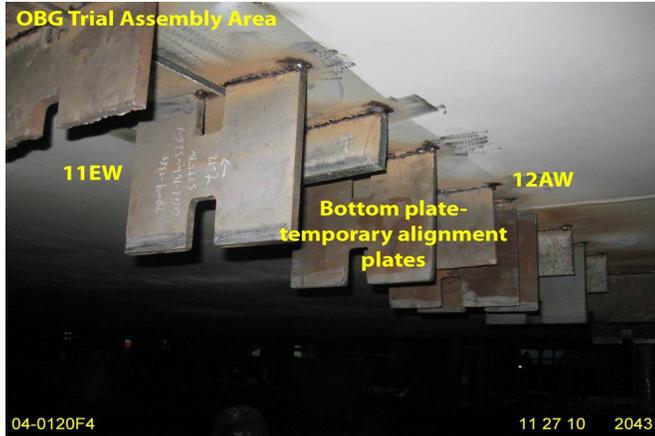
SMAW welding of temporary alignment plates outside on PCMK OBG 11EW/12AW, bottom plate to bottom plate. See photo below. Welder was identified as 057333. QC was identified as QC1. Assisting QC2 at this location and appearing to be monitoring the welding operation and recording data was ZPMC QC Zhou Peng (QCA1), who was not a CWI. Welding variables recorded by QCA1 appeared to comply with WPS-B-P-2114-FCM-1. Also present at this location and appearing to be monitoring the welding operation and recording data was ABF Representative Cao Hai Zhou.
