**DEPARTMENT OF TRANSPORTATION**

Contract #: 04-0120F4Cty: SF/ALA Rte: 80 PM: 13.2/13.9File #: 1.28**WELDING INSPECTION REPORT****Resident Engineer:** Siegenthaler, Peter**Address:** 333 Burma Road**City:** Oakland, CA 94607**Report No:** WIR-018710**Date Inspected:** 20-Dec-2010**Project Name:** SAS Superstructure**OSM Arrival Time:** 700**Prime Contractor:** American Bridge/Fluor Enterprises, a JV**OSM Departure Time:** 1530**Contractor:** American Bridge/Fluor Enterprises, a JV**Location:** Job Site**CWI Name:** Chuck Kanapicki**CWI Present:** Yes No**Inspected CWI report:** Yes No N/A**Rod Oven in Use:** Yes No N/A**Electrode to specification:** Yes No N/A**Weld Procedures Followed:** Yes No N/A**Qualified Welders:** Yes No N/A**Verified Joint Fit-up:** Yes No N/A**Approved Drawings:** Yes No N/A**Approved WPS:** Yes No N/A**Delayed / Cancelled:** Yes No N/A**Bridge No:** 34-0006**Component:** S.A.S. Components**Summary of Items Observed:**

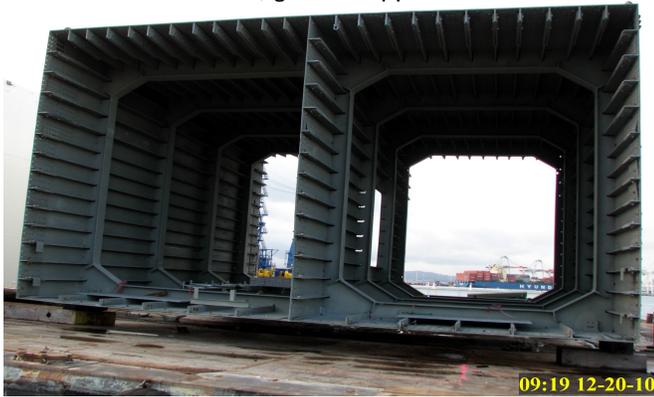
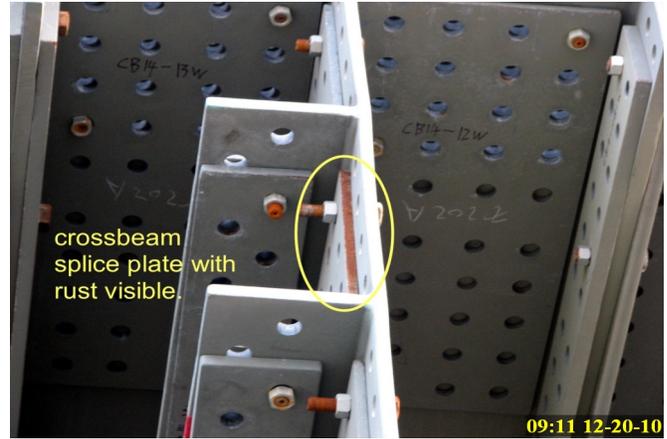
The QAI accompanied Caltrans representative Jason Wilcox and ABF representative Chuck Kanapicki in conducting the post arrival inspection of voyage 6 OBG crossbeams #13 and #14. During the inspection of the OBG crossbeams, the QAI noted that painted surfaces have been marred from general shipping and handling. The QAI noted that minor rusting is visible through the primer coating on the edges of the crossbeams at the field splice connections. The QAI noted there does not appear to be other shipping related damage. The QAI noted there are other components that have not been examined for post arrival at this time. The QAI was informed that additional post arrival inspections of components that are part of voyage 6 will be scheduled when ready. See the attached photos.

crossbeam 14, general appearance
