**DEPARTMENT OF TRANSPORTATION**

Contract #: 04-0120F4Cty: SF/ALA Rte: 80 PM: 13.2/13.9File #: 1.28**WELDING INSPECTION REPORT****Resident Engineer:** Siegenthaler, Peter**Address:** 333 Burma Road**City:** Oakland, CA 94607**Report No:** WIR-018715**Date Inspected:** 17-Dec-2010**Project Name:** SAS Superstructure**OSM Arrival Time:** 630**Prime Contractor:** American Bridge/Fluor Enterprises, a JV**OSM Departure Time:** 1500**Contractor:** American Bridge/Fluor Enterprises, a JV**Location:** Jobsite**CWI Name:** See below**CWI Present:** Yes No**Inspected CWI report:** Yes No N/A**Rod Oven in Use:** Yes No N/A**Electrode to specification:** Yes No N/A**Weld Procedures Followed:** Yes No N/A**Qualified Welders:** Yes No N/A**Verified Joint Fit-up:** Yes No N/A**Approved Drawings:** Yes No N/A**Approved WPS:** Yes No N/A**Delayed / Cancelled:** Yes No N/A**Bridge No:** 34-0006**Component:** SAS OBG**Summary of Items Observed:**

- 1). OBG Field Splice 8E/9E Weld ID: C2, Face A (SMAW)

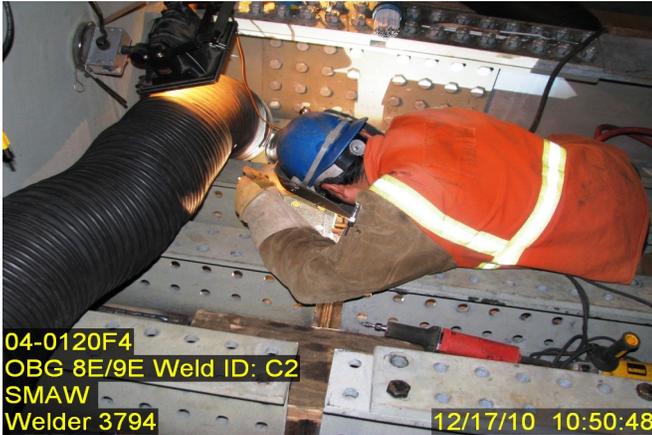
The QAI periodically observed AB/F approved welder Song Tao Huang (ID 3794) performing welding of fill and cover passes at the last 1000mm of OBG Field Splice 8E/9E Weld ID: C2. The welding was performed per the Shielded Metal Arc Welding (SMAW) process in the 3G (vertical) position. See photo below. The QAI observed QC Inspector Fred Von Hoff was present periodically to monitor the progress and verify that the welding parameters were within the limits established by the approved welding Procedure Specification (WPS) identified as ABF-WPS-D1.5-1040A. The welding of fill passes was completed and cover pass welding was in process. The QAI observed that the work at this location appeared to be in general compliance with contract documents.

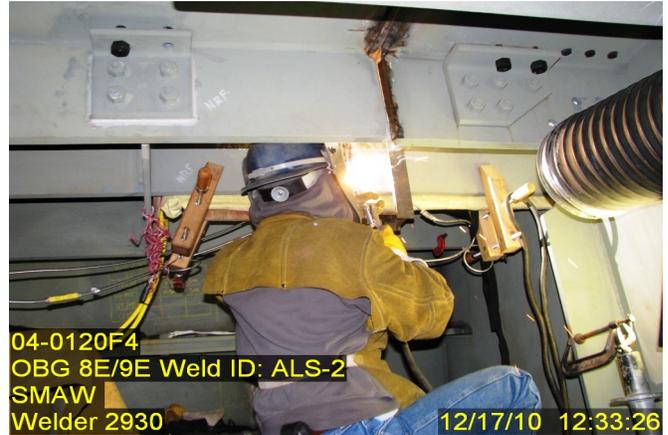
### 3). Longitudinal Stiffeners (ALS) Splice at OBG Field Splice 8E/9E (SMAW)

The QAI periodically observed AB/F approved welder Hua Qiang Hwang (ID 2930) at OBG Field Splice 8E/9E ALS-2, performing welding of root, fill and cover passes per the Shielded Metal Arc Welding (SMAW) process in the 3G (vertical) position. See photo below. The welding at this location was first from the North Face and was completed and back grinding of the South face and subsequent back welding was completed. QC Inspector Fred Von Hoff was present periodically to monitor the progress and verify that the welding parameters were within the limits established by the approved welding Procedure Specification (WPS) identified as ABF-WPS-D1.5-1012-3. The QAI observed that the work at this location appeared to be in general compliance with contract documents.
