Office of Structural Materials

Quality Assurance and Source Inspection

Contract #: 04-0120F4Cty: SF/ALA Rte: 80 PM: 13.2/13.9File #: 1.28**WELDING INSPECTION REPORT****Resident Engineer:** Siegenthaler, Peter**Address:** 333 Burma Road**City:** Oakland, CA 94607**Report No:** WIR-018716**Date Inspected:** 16-Dec-2010**Project Name:** SAS Superstructure**OSM Arrival Time:** 630**Prime Contractor:** American Bridge/Fluor Enterprises, a JV**OSM Departure Time:** 1500**Contractor:** American Bridge/Fluor Enterprises, a JV**Location:** Jobsite**CWI Name:** See below**CWI Present:** Yes No**Inspected CWI report:** Yes No N/A**Rod Oven in Use:** Yes No N/A**Electrode to specification:** Yes No N/A**Weld Procedures Followed:** Yes No N/A**Qualified Welders:** Yes No N/A**Verified Joint Fit-up:** Yes No N/A**Approved Drawings:** Yes No N/A**Approved WPS:** Yes No N/A**Delayed / Cancelled:** Yes No N/A**Bridge No:** 34-0006**Component:** SAS OBG**Summary of Items Observed:**

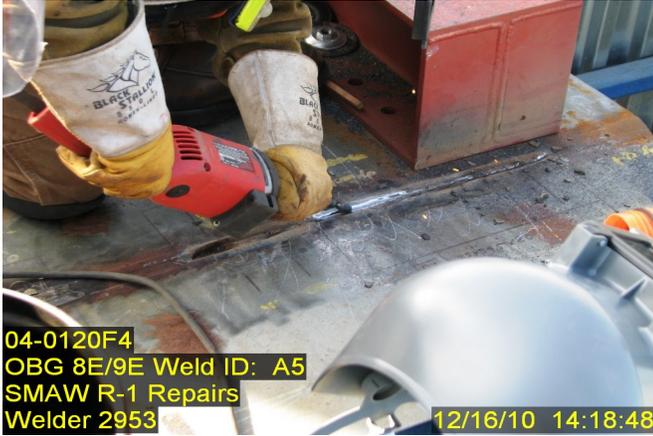
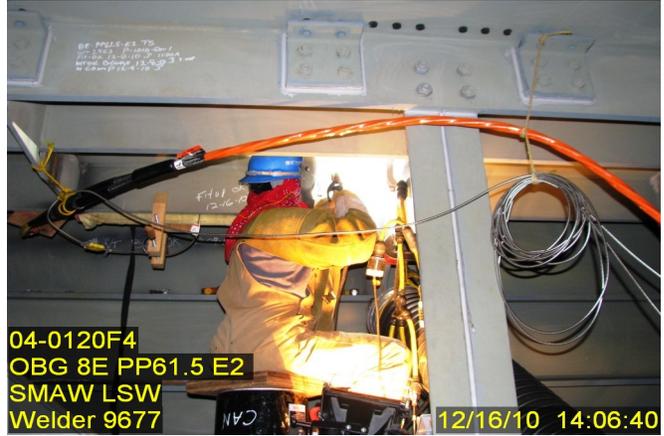
The QAI periodically observed AB/F approved welder Xiao Jian Wan (ID 9677) at OBG Field Splice 8E/9E ALS-6, performing back grinding of the South face and subsequent back welding of fill and cover passes per the Shielded Metal Arc Welding (SMAW) process in the 3G (vertical) position. See photo below. QC Inspector Fred Von Hoff were present periodically to monitor the progress and verify that the welding parameters were within the limits established by the approved welding Procedure Specification (WPS) identified as ABF-WPS-D1.5-1012-3. The welding and flush grinding was completed on the South face of ALS-6. The QAI observed that the work at this location appeared to be in general compliance with contract documents.
