DEPARTMENT OF TRANSPORTATION

Contract #: 04-0120F4Cty: SF/ALA Rte: 80 PM: 13.2/13.9File #: 1.28**WELDING INSPECTION REPORT****Resident Engineer:** Siegenthaler, Peter**Address:** 333 Burma Road**City:** Oakland, CA 94607**Report No:** WIR-018724**Date Inspected:** 16-Dec-2010**Project Name:** SAS Superstructure**OSM Arrival Time:** 1000**Prime Contractor:** American Bridge/Fluor Enterprises, a JV**OSM Departure Time:** 1830**Contractor:** American Bridge/Fluor Enterprises, a JV**Location:** Job Site

WELDING INSPECTION REPORT

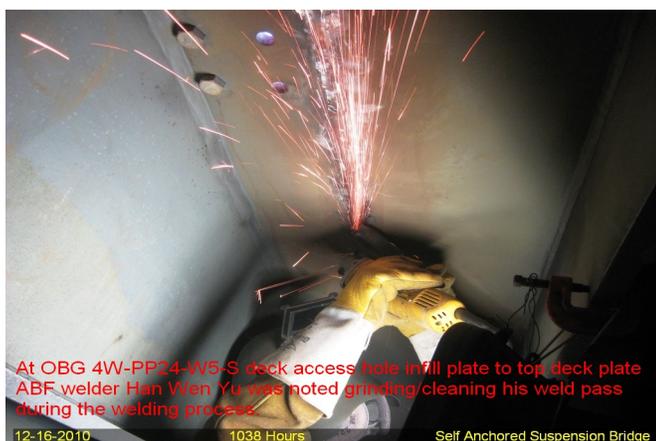
12-16-2010 1038 Hours Self Anchored Suspension Bridge

2. At OBG 4W-PP24-W5-S outside - ABF welder Han Wen Yu was observed continuing to perform 4G Shielded Metal Arc Welding (SMAW) back welding fill pass on the infill plate to top deck plate butt joint. The welder was noted using 1/8" diameter E7018H4R electrode. At the end of the shift, fill pass welding was still in progress and should continue tomorrow.

At OBG 4W-PP24-W5-S deck access hole infill plate to top deck plate ABF welder Han Wan Yu was noted grinding/cleaning his weld pass during the welding process.

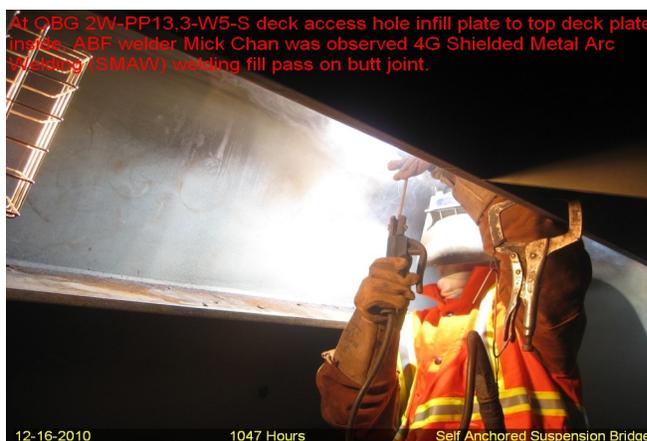
12-16-2010 1047 Hours Self Anchored Suspension Bridge

3. At OBG 2W-PP13.5-W5-S inside – ABF welder Mick Chan was observed continuing to perform 4G Shielded Metal Arc Welding (SMAW) back welding fill pass on the infill plate to top deck plate butt joint. The welder was noted using 1/8" diameter E7018H4R electrode. At the end of the shift, fill pass welding was still in progress and should continue tomorrow.

At OBG 2W-PP13,3-W5-S deck access hole infill plate to top deck plate inside ABF welder Mick Chan was observed 4G Shielded Metal Arc Welding (SMAW) welding fill pass on butt joint.
