**DEPARTMENT OF TRANSPORTATION**

Quality Assurance and Source Inspection

Contract #: 04-0120F4Cty: SF/ALA Rte: 80 PM: 13.2/13.9File #: 69.28**WELDING INSPECTION REPORT****Resident Engineer:** Siegenthaler, Peter**Address:** 333 Burma Road**City:** Oakland, CA 94607**Report No:** WIR-018740**Date Inspected:** 18-Dec-2010**Project Name:** SAS Superstructure**OSM Arrival Time:** 700**Prime Contractor:** American Bridge/Fluor Enterprises, a JV**OSM Departure Time:** 1900**Contractor:** Zhenhua Port Machinery Company, Ltd (ZPMC), Changxing Island **Location:** Shanghai, China**CWI Name:** Mr. Zhu Zhong Hai.**CWI Present:** Yes No**Inspected CWI report:** Yes No N/A**Rod Oven in Use:** Yes No N/A**Electrode to specification:** Yes No N/A**Weld Procedures Followed:** Yes No N/A**Qualified Welders:** Yes No N/A**Verified Joint Fit-up:** Yes No N/A**Approved Drawings:** Yes No N/A**Approved WPS:** Yes No N/A**Delayed / Cancelled:** Yes No N/A**Bridge No:** 34-0006**Component:** Orthotropic Box Girder (OBG)**Summary of Items Observed:**

**OBG TRIAL ASSEMBLY****OBG Segment 12AE~12BE**

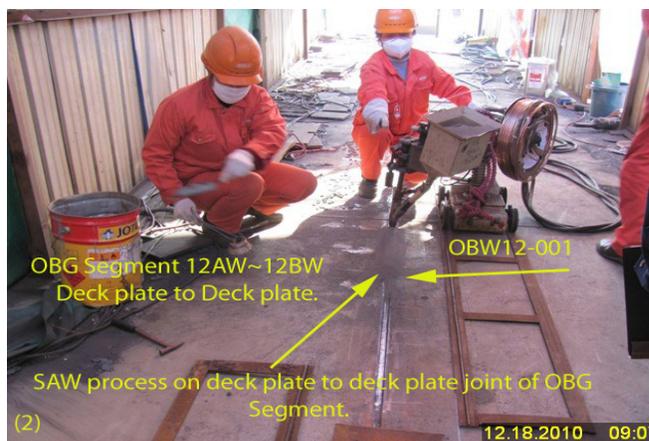
This QA Inspector observed ZPMC qualified welding personnel identified as 044560 Perform Submerged Arc Welding (SAW) on OBG segment 12AW+12BW Deck plate to deck plate joint. Joint identified as OBW12-001. ZPMC QC Identified as Wang Zhu. The welding parameters as measured using QC's calibrated instrument appeared to be in general compliance with WPS-B-T-223(2) 1 T-ESAB. For more information see below attached picture number 2.
