DEPARTMENT OF TRANSPORTATION

Quality Assurance and Source Inspection

Contract #: 04-0120F4Cty: SF/ALA Rte: 80 PM: 13.2/13.9File #: 69.28**WELDING INSPECTION REPORT****Resident Engineer:** Siegenthaler, Peter**Address:** 333 Burma Road**City:** Oakland, CA 94607**Report No:** WIR-018742**Date Inspected:** 29-Sep-2010**Project Name:** SAS Superstructure**OSM Arrival Time:** 700**Prime Contractor:** American Bridge/Fluor Enterprises, a JV**OSM Departure Time:** 1900**Contractor:** Zhenhua Port Machinery Company, Ltd (ZPMC), Changxing Island **Location:** Shanghai, China**CWI Name:** Lin Fe Wen**CWI Present:** Yes No**Inspected CWI report:** Yes No N/A**Rod Oven in Use:** Yes No N/A**Electrode to specification:** Yes No N/A**Weld Procedures Followed:** Yes No N/A**Qualified Welders:** Yes No N/A**Verified Joint Fit-up:** Yes No N/A**Approved Drawings:** Yes No N/A**Approved WPS:** Yes No N/A**Delayed / Cancelled:** Yes No N/A**Bridge No:** 34-0006**Component:** OBG COMPONENT**Summary of Items Observed:**

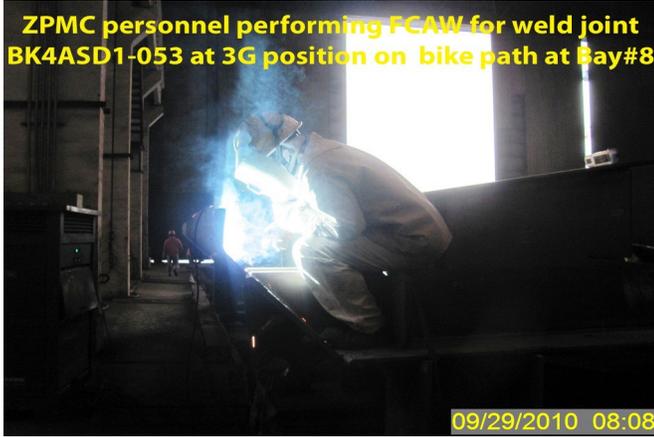
FCAW in the 3G position for the OBG bike path joint, weld No.BK004SD1-053. The welder is identified as #067947. ZPMC QC is identified as Mr.Lin Fe Wen .The welding variables recorded by QC appear to comply with WPS-B-T-2233-B-U2-F.

ZPMC personnel performing FCAW for weld joint BK4ASD1-053 at 3G position on bike path at Bay#8

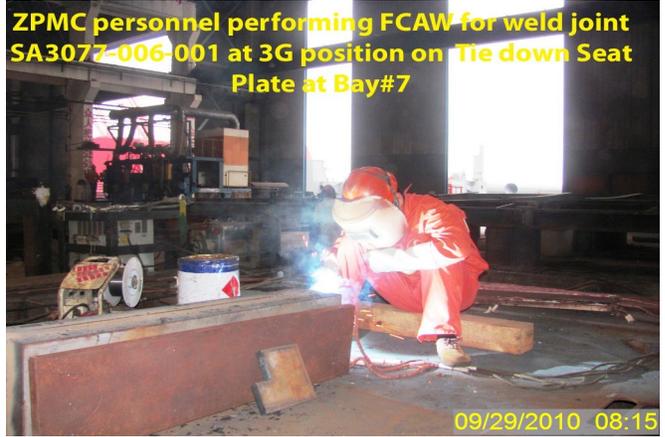
FCAW in the 3G position for the OBG Tie down Seat plate joint, weld No.SA3077-006-001. The welder is identified as #051246. ZPMC QC is identified as Mr.Wang Li Yang.The welding variables recorded by QC appear to comply with WPS-B-T-2333-C-P2-F.

ZPMC personnel performing FCAW for weld joint SA3077-006-001 at 3G position on Tie down Seat Plate at Bay#7

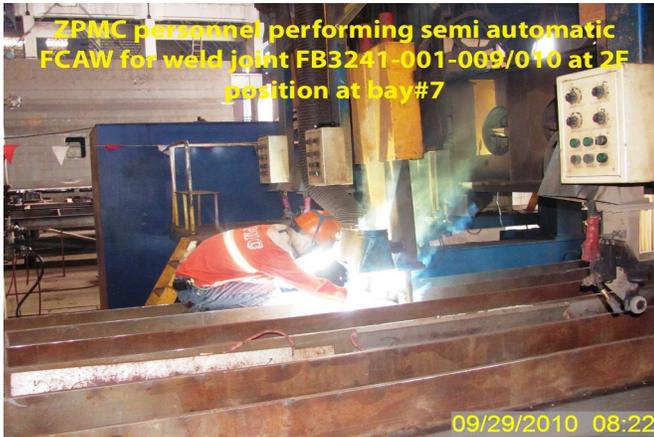
FCAW in the 2F position for the OBG Floor Beam joint, weld No.FB3241-001-009/010. The welder is identified as #062447. ZPMC QC is identified as Mr. Wang Li Yang.The welding variables recorded by QC appear to comply with WPS-B-T-2132-3.

ZPMC personnel performing semi automatic FCAW for weld joint FB3241-001-009/010 at 2F position at bay#7

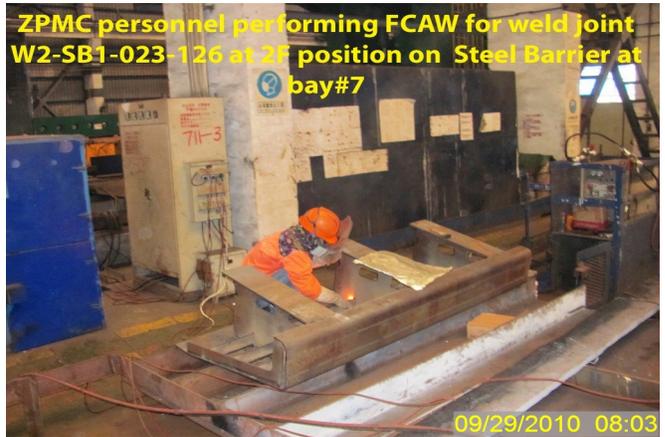
ZPMC personnel performing FCAW for weld joint W2-SB1-023-126 at 2F position on Steel Barrier at bay#7

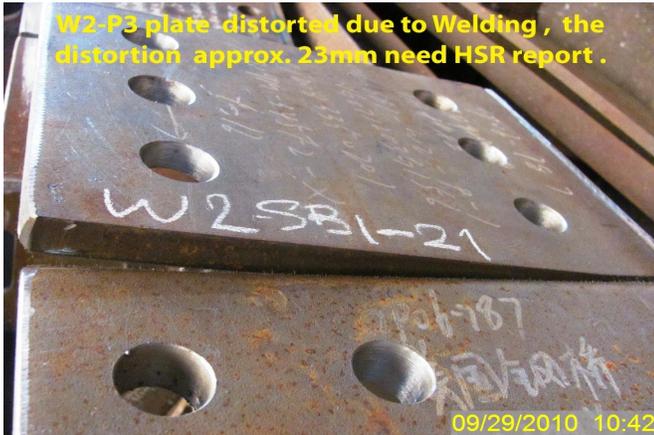
W2-P3 plate distorted due to Welding , the distortion approx. 23mm need HSR report .
