**DEPARTMENT OF TRANSPORTATION**

Contract #: 04-0120F4Cty: SF/ALA Rte: 80 PM: 13.2/13.9File #: 1.28**WELDING INSPECTION REPORT****Resident Engineer:** Siegenthaler, Peter**Address:** 333 Burma Road**City:** Oakland, CA 94607**Report No:** WIR-018801**Date Inspected:** 21-Dec-2010**Project Name:** SAS Superstructure**OSM Arrival Time:** 900**Prime Contractor:** American Bridge/Fluor Enterprises, a JV**OSM Departure Time:** 1730**Contractor:** American Bridge/Fluor Enterprises, a JV**Location:** Jobsite**CWI Name:** See below**CWI Present:** Yes No**Inspected CWI report:** Yes No N/A**Rod Oven in Use:** Yes No N/A**Electrode to specification:** Yes No N/A**Weld Procedures Followed:** Yes No N/A**Qualified Welders:** Yes No N/A**Verified Joint Fit-up:** Yes No N/A**Approved Drawings:** Yes No N/A**Approved WPS:** Yes No N/A**Delayed / Cancelled:** Yes No N/A**Bridge No:** 34-0006**Component:** SAS OBG**Summary of Items Observed:**

## WELDING INSPECTION REPORT

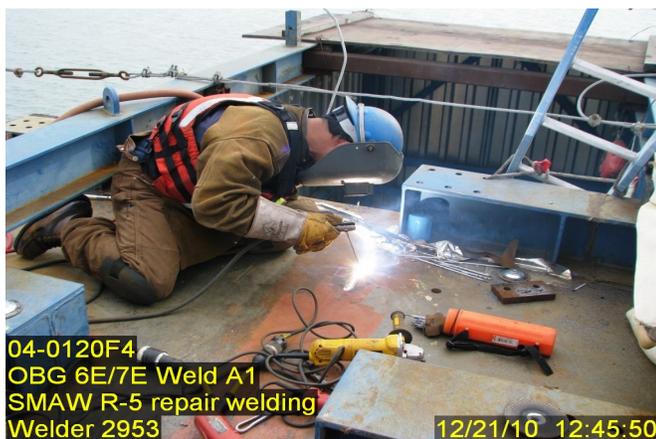
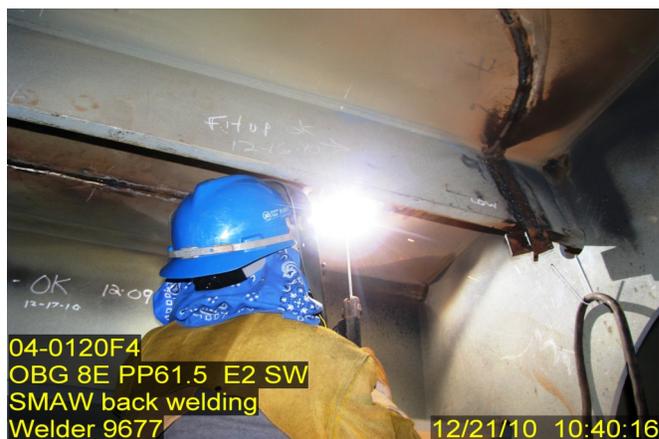
The OBG Field Splice verified by the QAI appeared to be in general compliance with contract documents. See Ultrasonic Testing Report Form TL-6027 generated by the QAI on this date.
