DEPARTMENT OF TRANSPORTATION

Contract #: 04-0120F4Cty: SF/ALA Rte: 80 PM: 13.2/13.9File #: 69.28**WELDING INSPECTION REPORT****Resident Engineer:** Siegenthaler, Peter**Address:** 333 Burma Road**City:** Oakland, CA 94607**Report No:** WIR-018867**Date Inspected:** 28-Dec-2010**Project Name:** SAS Superstructure**OSM Arrival Time:** 700**Prime Contractor:** American Bridge/Fluor Enterprises, a JV**OSM Departure Time:** 1900**Contractor:** Zhenhua Port Machinery Company, Ltd (ZPMC), Changxing Island **Location:** Shanghai, China**CWI Name:** Liu Hua Jie**CWI Present:** Yes No**Inspected CWI report:** Yes No N/A**Rod Oven in Use:** Yes No N/A**Electrode to specification:** Yes No N/A**Weld Procedures Followed:** Yes No N/A**Qualified Welders:** Yes No N/A**Verified Joint Fit-up:** Yes No N/A**Approved Drawings:** Yes No N/A**Approved WPS:** Yes No N/A**Delayed / Cancelled:** Yes No N/A**Bridge No:** 34-0006**Component:** OBG COMPONENT**Summary of Items Observed:**

WELDING INSPECTION REPORT

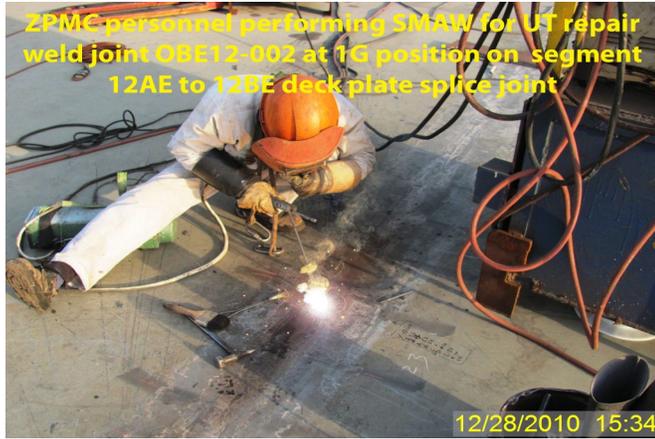
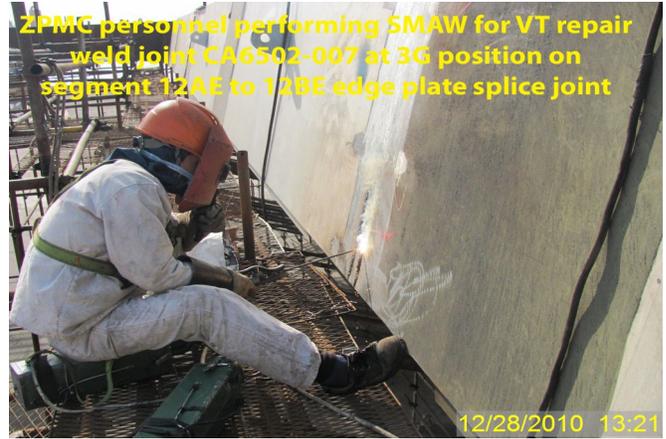
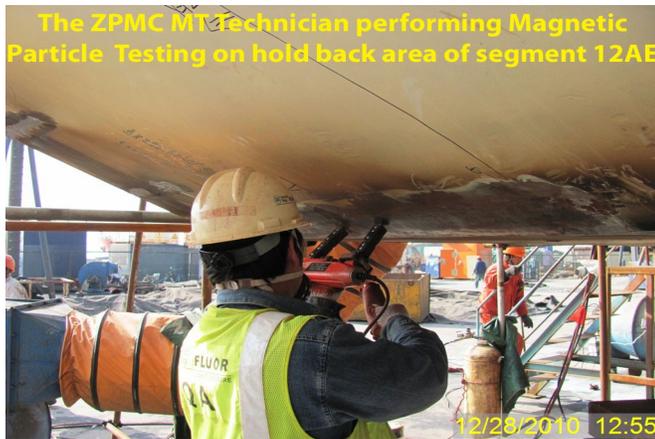
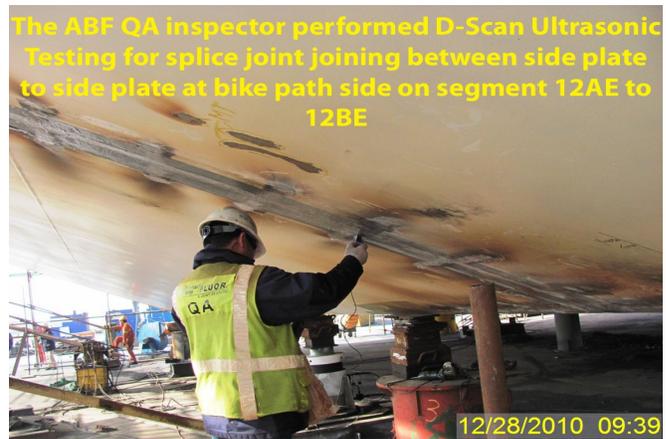
SMAW in the 4G position for the OBG Segment 12AE to 12BE for splice joint of side plate to side plate at cross beam side, VT repair weld No. OBE12D-002. The welder is identified as #044515. ZPMC QC is identified as Mr. An Qing Xing. The welding variables recorded by QC appear to comply with WPS-345-SMAW-4G(4F)-FCM-REPAIR-1. The repair report is identified as WR19703.

SMAW in the 3G position for the OBG Segment 12AE to 12BE for splice joint of edge plate to edge plate at cross beam side, VT repair weld No. OBE12-001. The welder is identified as #050289. ZPMC QC is identified as Mr. An Qing Xing. The welding variables recorded by QC appear to comply with WPS-345-SMAW-3G(3F)-FCM-REPAIR-1. The repair report is identified as WR19618.

SMAW in the 4F position for the OBG Segment 12AW weld No.DP3039-001-018/019. The welder is identified as #041713. ZPMC QC is identified as Mr. Shi Lei. The welding variables recorded by QC appear to comply with WPS-B-T-2114-1.

SMAW in the 1G position for the OBG Segment 12AE to 12BE for UT repair weld No.OBE12-002/003. The welder is identified as #044515. ZPMC QC is identified as Mr. An Qing Xing. The welding variables recorded by QC appear to comply with WPS-345-SMAW-1G(1F)-FCM-REPAIR-1. The repair report is identified as WR19643.
