**DEPARTMENT OF TRANSPORTATION**

Contract #: 04-0120F4Cty: SF/Ala Rte: 80 PM: 13.2/13.9File #: 69.28**WELDING INSPECTION REPORT****Resident Engineer:** Siegenthaler, Peter**Address:** 333 Burma Road**City:** Oakland, CA 94607**Report No:** WIR-018895**Date Inspected:** 22-Dec-2010**Project Name:** SAS Superstructure**OSM Arrival Time:** 1900**Prime Contractor:** American Bridge/Fluor Enterprises, a JV**OSM Departure Time:** 700**Contractor:** Zhenhua Port Machinery Company, Ltd (ZPMC), Changxing Island **Location:** Shanghai, China**CWI Name:** See below**CWI Present:** Yes No**Inspected CWI report:** Yes No N/A**Rod Oven in Use:** Yes No N/A**Electrode to specification:** Yes No N/A**Weld Procedures Followed:** Yes No N/A**Qualified Welders:** Yes No N/A**Verified Joint Fit-up:** Yes No N/A**Approved Drawings:** Yes No N/A**Approved WPS:** Yes No N/A**Delayed / Cancelled:** Yes No N/A**Bridge No:** 34-0006**Component:** OBG and Tower Components**Summary of Items Observed:**

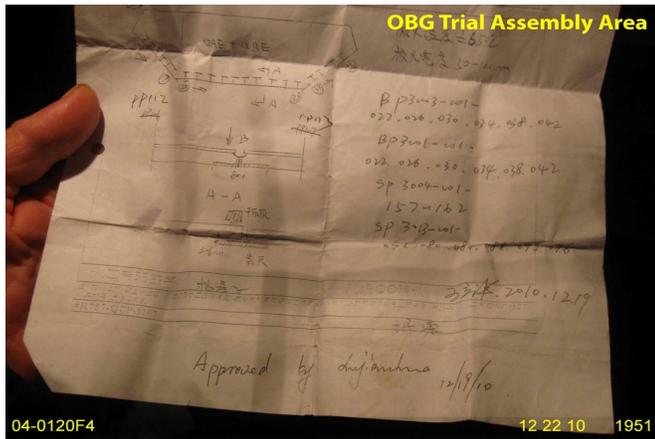
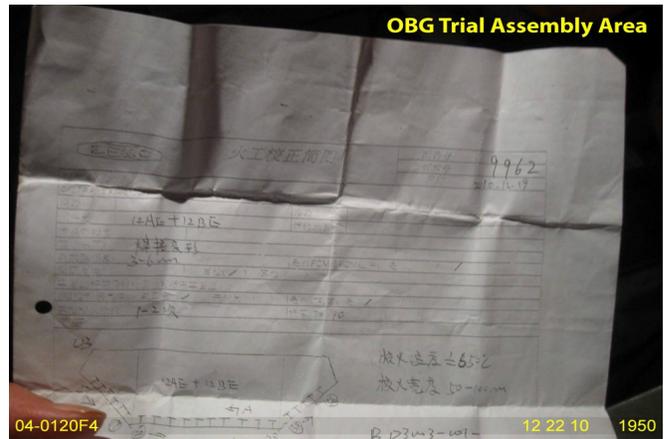
Heat straightening of various weld joints located on PCMK OBG 12AE/12BE, side plate stiffener to side plate stiffener, south (bikepath) side, at transverse joint. QC was identified as ZPMC CWI Gu Rong Jiang (QC1). Assisting QC1 at this location and appearing to be monitoring the heat straightening operation and recording data was ZPMC QC Zhu Yuan Yuan (QCA1), who was not a CWI. Heat treatment variables recorded by QCA1 appeared to comply with ZPMC document HSR1(B)-9962 as presented to this QA Inspector and verbally

identified by QCA1. See photos of document below as presented to this QA Inspector.
