DEPARTMENT OF TRANSPORTATION

Contract #: 04-0120F4Cty: SF/ALA Rte: 80 PM: 13.2/13.9File #: 1.28**WELDING INSPECTION REPORT****Resident Engineer:** Siegenthaler, Peter**Address:** 333 Burma Road**City:** Oakland, CA 94607**Report No:** WIR-018910**Date Inspected:** 28-Dec-2010**Project Name:** SAS Superstructure**OSM Arrival Time:** 630**Prime Contractor:** American Bridge/Fluor Enterprises, a JV**OSM Departure Time:** 1500**Contractor:** American Bridge/Fluor Enterprises, a JV**Location:** Jobsite**CWI Name:** See below**CWI Present:** Yes No**Inspected CWI report:** Yes No N/A**Rod Oven in Use:** Yes No N/A**Electrode to specification:** Yes No N/A**Weld Procedures Followed:** Yes No N/A**Qualified Welders:** Yes No N/A**Verified Joint Fit-up:** Yes No N/A**Approved Drawings:** Yes No N/A**Approved WPS:** Yes No N/A**Delayed / Cancelled:** Yes No N/A**Bridge No:** 34-0006**Component:** SAS OBG**Summary of Items Observed:**

WELDING INSPECTION REPORT

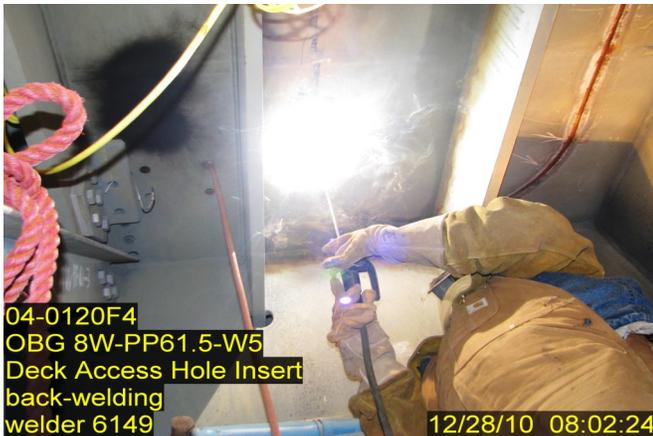
3). OBG West Line Deck Access Hole Insert at 8W PP61.5 W5 (SMAW back welding)

The QAI periodically observed AB/F approved welder Jorge Lopez (ID 6149) performing back welding the per the Shielded Metal Arc Welding (SMAW) process in the 4G (overhead) position on the interior of the OBG West Line Deck Access Hole Insert 8W PP61.5 W5. See photo below. QC Inspector Gary Ehram was present periodically to monitor the progress and verify that the welding parameters were within the limits established by the approved welding Procedure Specification (WPS) identified as ABF-WPS-D1.5-1010 rev 1. Welding was in process and the QAI observed the work at this location appeared to be in general compliance with contract documents.

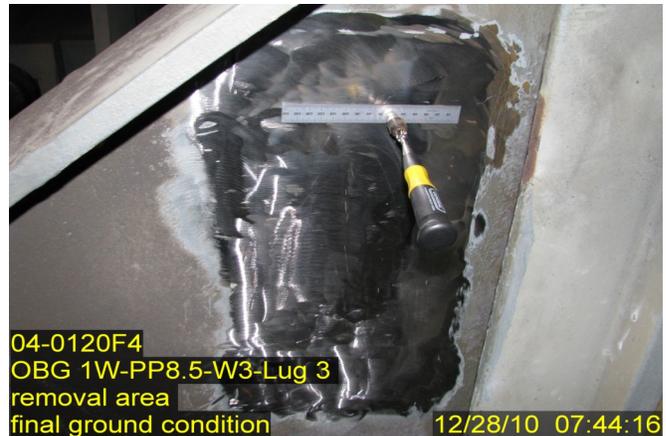
4). OBG Lifting Lug Removal – (Air Carbon Arc gouging & grinding)

The QAI periodically observed AB/F apprentice Ian Murphy performing Air Carbon Arc gouging to remove the lifting lug at 1W PP9.5 W3 Lifting Lug #3 and AB/F personnel performing grinding and sanding of removal areas at 1W PP8.5 W4 Lifting Lug #2 & W3 Lifting Lug #3. See photo below. The work at this location was per ABF-RFI-001151R01.
