DEPARTMENT OF TRANSPORTATION

Contract #: 04-0120F4Cty: SF/ALA Rte: 80 PM: 13.2/13.9File #: 69.28**WELDING INSPECTION REPORT****Resident Engineer:** Siegenthaler, Peter**Address:** 333 Burma Road**City:** Oakland, CA 94607**Report No:** WIR-018921**Date Inspected:** 30-Dec-2010**Project Name:** SAS Superstructure**OSM Arrival Time:** 700**Prime Contractor:** American Bridge/Fluor Enterprises, a JV**OSM Departure Time:** 1900**Contractor:** Zhenhua Port Machinery Company, Ltd (ZPMC), Changxing Island **Location:** Shanghai, China**CWI Name:** Li Yang**CWI Present:** Yes No**Inspected CWI report:** Yes No N/A**Rod Oven in Use:** Yes No N/A**Electrode to specification:** Yes No N/A**Weld Procedures Followed:** Yes No N/A**Qualified Welders:** Yes No N/A**Verified Joint Fit-up:** Yes No N/A**Approved Drawings:** Yes No N/A**Approved WPS:** Yes No N/A**Delayed / Cancelled:** Yes No N/A**Bridge No:** 34-0006**Component:** OBG Segment**Summary of Items Observed:**

WELDING INSPECTION REPORT

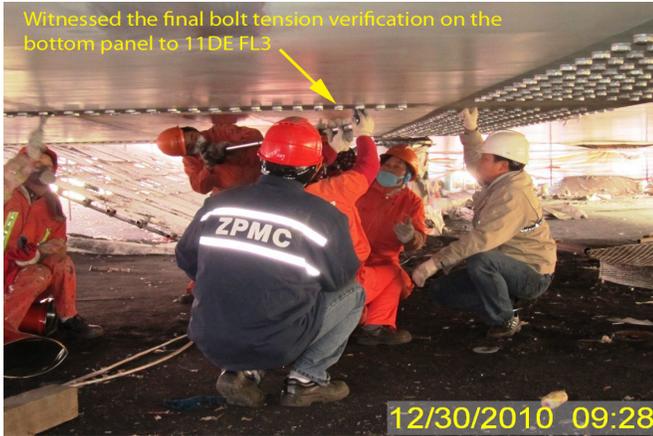
This QA Inspector witnessed the final bolt tension verification on the bottom panel to 11DE FL3. The torque wrench S/N was X02-666. The QA Inspector witnessed 10% of the bolts on a random basis and found the tensioning of the bolts appeared to be in general compliance with the contract specifications. The bolt size designations were as follows:
