DEPARTMENT OF TRANSPORTATION

Quality Assurance and Source Inspection

Contract #: 04-0120F4Cty: SF/ALA Rte: 80 PM: 13.2/13.9File #: 69.28**WELDING INSPECTION REPORT****Resident Engineer:** Siegenthaler, Peter**Address:** 333 Burma Road**City:** Oakland, CA 94607**Report No:** WIR-018938**Date Inspected:** 03-Dec-2010**Project Name:** SAS Superstructure**OSM Arrival Time:** 700**Prime Contractor:** American Bridge/Fluor Enterprises, a JV**OSM Departure Time:** 1900**Contractor:** Zhenhua Port Machinery Company, Ltd (ZPMC), Changxing Island **Location:** Shanghai, China**CWI Name:** Mr. Xu Le Feng**CWI Present:** Yes No**Inspected CWI report:** Yes No N/A**Rod Oven in Use:** Yes No N/A**Electrode to specification:** Yes No N/A**Weld Procedures Followed:** Yes No N/A**Qualified Welders:** Yes No N/A**Verified Joint Fit-up:** Yes No N/A**Approved Drawings:** Yes No N/A**Approved WPS:** Yes No N/A**Delayed / Cancelled:** Yes No N/A**Bridge No:** 34-0006**Component:** Tower / OBG**Summary of Items Observed:**

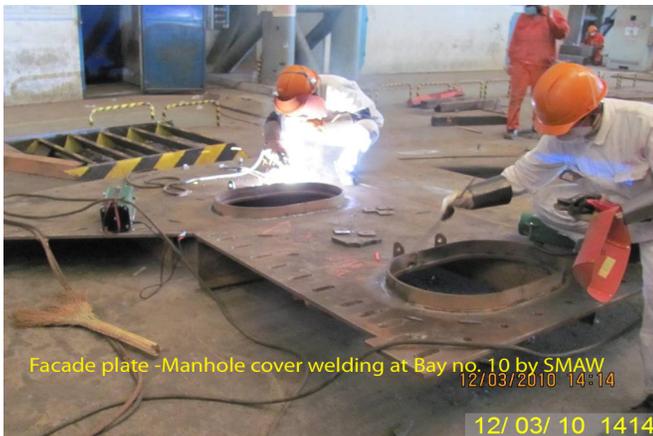
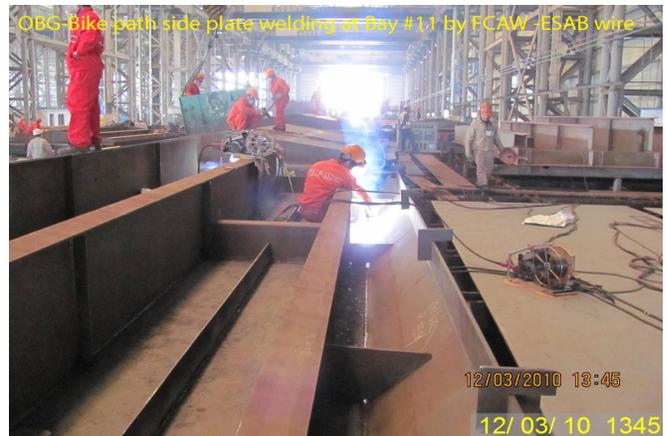
This QA inspector performed (MT) of approximately 15% of an area that has been previously tested and accepted by ZPMC Quality Control (QC) personnel. This QA Inspector generated a TL 6028 MT report for this date. The member is identified as OBG Bike path components. The weld designations reviewed are as follows:

BK004ASD1 -022 – Jt. nos. -011, 019, 20, 07, 12

BK004A8 -023 – Jt. no -036

Unless otherwise noted, all work observed on this date appeared to be in general compliance with the applicable contract documents.
