**DEPARTMENT OF TRANSPORTATION**

Contract #: 04-0120F4Cty: SF/ALA Rte: 80 PM: 13.2/13.9File #: 69.28**WELDING INSPECTION REPORT****Resident Engineer:** Siegenthaler, Peter**Address:** 333 Burma Road**City:** Oakland, CA 94607**Report No:** WIR-018941**Date Inspected:** 06-Dec-2010**Project Name:** SAS Superstructure**OSM Arrival Time:** 700**Prime Contractor:** American Bridge/Fluor Enterprises, a JV**OSM Departure Time:** 1900**Contractor:** Zhenhua Port Machinery Company, Ltd (ZPMC), Changxing Island **Location:** Shanghai, China**CWI Name:** Mr. Xu Le Feng**CWI Present:** Yes No**Inspected CWI report:** Yes No N/A**Rod Oven in Use:** Yes No N/A**Electrode to specification:** Yes No N/A**Weld Procedures Followed:** Yes No N/A**Qualified Welders:** Yes No N/A**Verified Joint Fit-up:** Yes No N/A**Approved Drawings:** Yes No N/A**Approved WPS:** Yes No N/A**Delayed / Cancelled:** Yes No N/A**Bridge No:** 34-0006**Component:** Tower / OBG**Summary of Items Observed:**

# WELDING INSPECTION REPORT

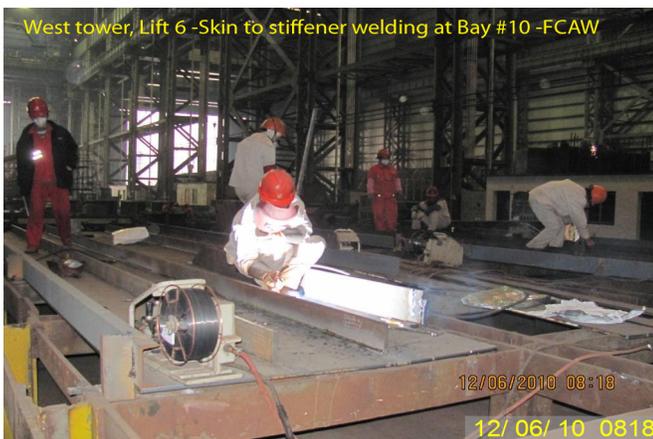
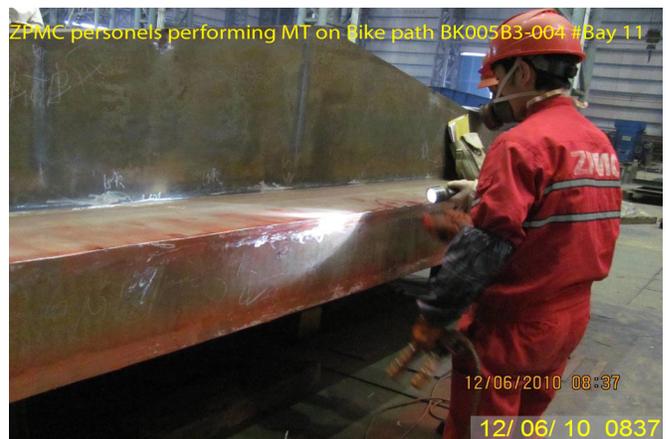
For further information see below pictures:-

Unless otherwise noted, all work observed on this date appeared to be in general compliance with the applicable contract documents.
