**DEPARTMENT OF TRANSPORTATION**

Contract #: 04-0120F4Cty: SF/ALA Rte: 80 PM: 13.2/13.9File #: 69.28**WELDING INSPECTION REPORT****Resident Engineer:** Siegenthaler, Peter**Address:** 333 Burma Road**City:** Oakland, CA 94607**Report No:** WIR-018943**Date Inspected:** 09-Dec-2010**Project Name:** SAS Superstructure**OSM Arrival Time:** 700**Prime Contractor:** American Bridge/Fluor Enterprises, a JV**OSM Departure Time:** 1900**Contractor:** Zhenhua Port Machinery Company, Ltd (ZPMC), Changxing Island **Location:** Shanghai, China**CWI Name:** Mr. Xu Le Feng**CWI Present:** Yes No**Inspected CWI report:** Yes No N/A**Rod Oven in Use:** Yes No N/A**Electrode to specification:** Yes No N/A**Weld Procedures Followed:** Yes No N/A**Qualified Welders:** Yes No N/A**Verified Joint Fit-up:** Yes No N/A**Approved Drawings:** Yes No N/A**Approved WPS:** Yes No N/A**Delayed / Cancelled:** Yes No N/A**Bridge No:** 34-0006**Component:** Tower / OBG**Summary of Items Observed:**

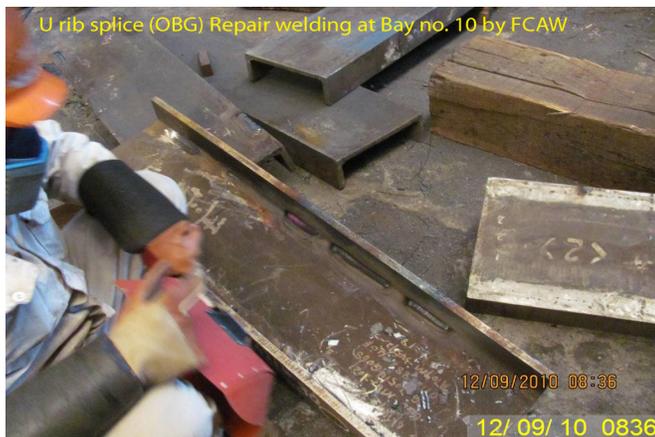
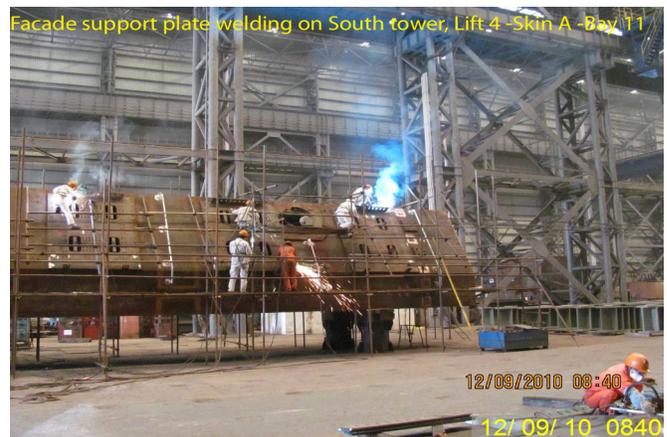
For further information see below pictures:-

Unless otherwise noted, all work observed on this date appeared to be in general compliance with the applicable contract documents.
