**DEPARTMENT OF TRANSPORTATION**

Quality Assurance and Source Inspection

Contract #: 04-0120F4Cty: SF/ALA Rte: 80 PM: 13.2/13.9File #: 69.28**WELDING INSPECTION REPORT****Resident Engineer:** Siegenthaler, Peter**Address:** 333 Burma Road**City:** Oakland, CA 94607**Report No:** WIR-018948**Date Inspected:** 03-Dec-2010**Project Name:** SAS Superstructure**OSM Arrival Time:** 700**Prime Contractor:** American Bridge/Fluor Enterprises, a JV**OSM Departure Time:** 1900**Contractor:** Zhenhua Port Machinery Company, Ltd (ZPMC), Changxing Island **Location:** Shanghai, China**CWI Name:** Xu Le Feng**CWI Present:** Yes No**Inspected CWI report:** Yes No N/A**Rod Oven in Use:** Yes No N/A**Electrode to specification:** Yes No N/A**Weld Procedures Followed:** Yes No N/A**Qualified Welders:** Yes No N/A**Verified Joint Fit-up:** Yes No N/A**Approved Drawings:** Yes No N/A**Approved WPS:** Yes No N/A**Delayed / Cancelled:** Yes No N/A**Bridge No:** 34-0006**Component:** TOWER & OBG Components**Summary of Items Observed:**

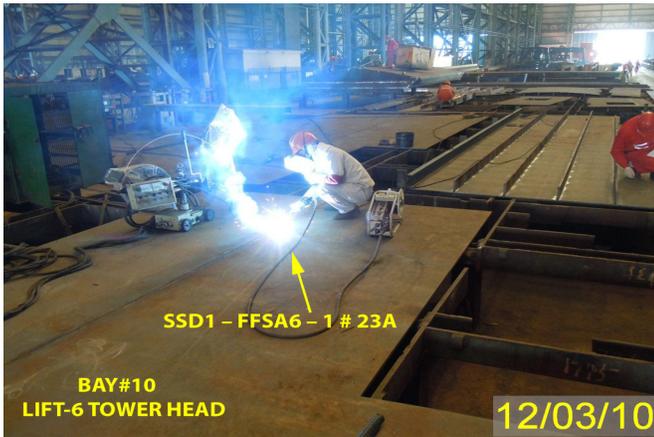
Weld joint # 23A located on Lift-6 tower head component SSD1 – FFSA6 – 1. Welder is identified as 052075. ZPMC Quality Control (QC) Inspector is identified as Deng Zhi Bing. The welding variables recorded by QC appeared to comply with the WPS – B – T – 2231 – B – U2 – F. (See the attached photo)

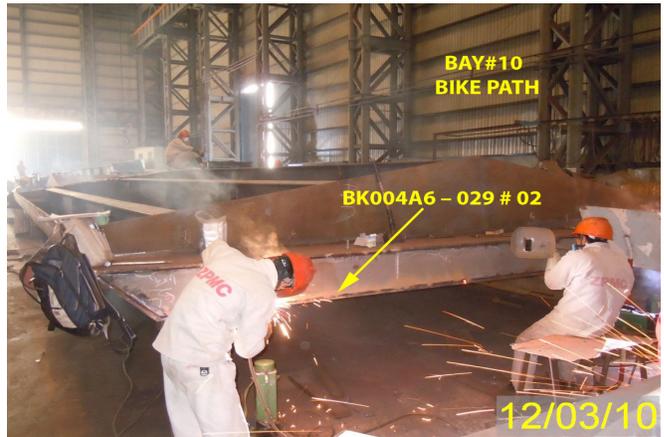
Weld joint # 02 located on Bike Path BK004A6 – 029. Welder is identified as 052493. ZPMC Quality Control (QC) Inspector is identified as Yu Zhi Lai. The welding variables recorded by QC appeared to comply with the WPS – B – T – 2312 – Tc – P4. (See attached photo)
