DEPARTMENT OF TRANSPORTATION

Contract #: 04-0120F4Cty: SF/ALA Rte: 80 PM: 13.2/13.9File #: 69.28**WELDING INSPECTION REPORT****Resident Engineer:** Siegenthaler, Peter**Address:** 333 Burma Road**City:** Oakland, CA 94607**Report No:** WIR-018956**Date Inspected:** 12-Dec-2010**Project Name:** SAS Superstructure**OSM Arrival Time:** 700**Prime Contractor:** American Bridge/Fluor Enterprises, a JV**OSM Departure Time:** 1900**Contractor:** Zhenhua Port Machinery Company, Ltd (ZPMC), Changxing Island **Location:** Shanghai, China**CWI Name:** Mr. Xu Le Feng**CWI Present:** Yes No**Inspected CWI report:** Yes No N/A**Rod Oven in Use:** Yes No N/A**Electrode to specification:** Yes No N/A**Weld Procedures Followed:** Yes No N/A**Qualified Welders:** Yes No N/A**Verified Joint Fit-up:** Yes No N/A**Approved Drawings:** Yes No N/A**Approved WPS:** Yes No N/A**Delayed / Cancelled:** Yes No N/A**Bridge No:** 34-0006**Component:** Tower / OBG**Summary of Items Observed:**

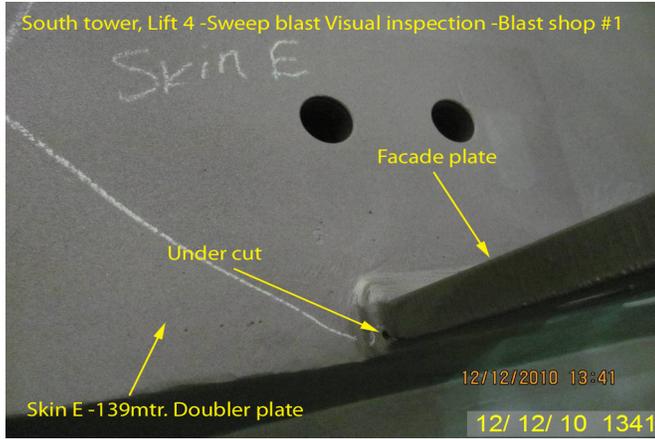
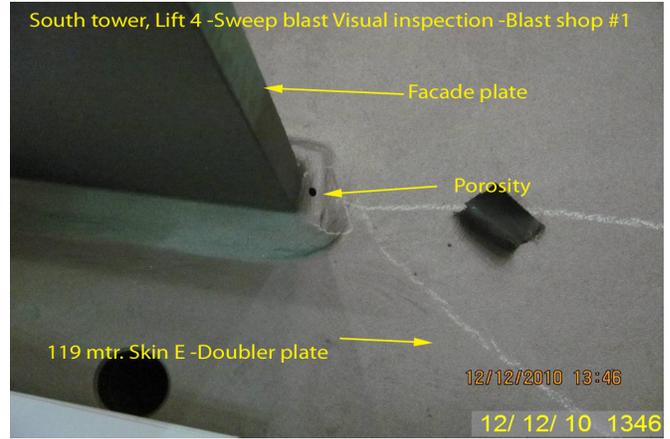
This QA inspector, Baskar Govindarajan, performed Post blast inspection of external surfaces of South tower, Lift 4. All the areas marked which requires grinding, weld repair, Grinding & MT wherever applicable in all the Skins of Tower from 114 mtr. to 146 mtr. Elevation. This inspection was carried out along with QA Inspector Mr. Robin Sharma (B 309), Mr. Scott (B 319), Mr. Anand Upadhye (B 297), and Mr. Vikram (B 300) . All the marked points shown to ZPMC inspector Mr. Zhao Chen Sun and ABF Inspector Mr. Xing Xiao Guang. All the weld repair areas (9 nos) marked in weld map in detail and the same was signed by ZPMC and ABF Inspector.
