DEPARTMENT OF TRANSPORTATION

Contract #: 04-0120F4Cty: SF/ALA Rte: 80 PM: 13.2/13.9File #: 69.28**WELDING INSPECTION REPORT****Resident Engineer:** Siegenthaler, Peter**Address:** 333 Burma Road**City:** Oakland, CA 94607**Report No:** WIR-018959**Date Inspected:** 13-Dec-2010**Project Name:** SAS Superstructure**OSM Arrival Time:** 700**Prime Contractor:** American Bridge/Fluor Enterprises, a JV**OSM Departure Time:** 1900**Contractor:** Zhenhua Port Machinery Company, Ltd (ZPMC), Changxing Island **Location:** Shanghai, China**CWI Name:** Zhao Chen Sun**CWI Present:** Yes No**Inspected CWI report:** Yes No N/A**Rod Oven in Use:** Yes No N/A**Electrode to specification:** Yes No N/A**Weld Procedures Followed:** Yes No N/A**Qualified Welders:** Yes No N/A**Verified Joint Fit-up:** Yes No N/A**Approved Drawings:** Yes No N/A**Approved WPS:** Yes No N/A**Delayed / Cancelled:** Yes No N/A**Bridge No:** 34-0006**Component:** TOWER Components**Summary of Items Observed:**

WELDING INSPECTION REPORT

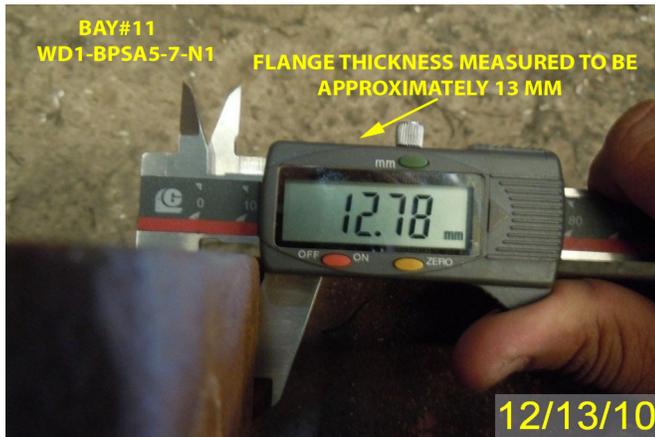
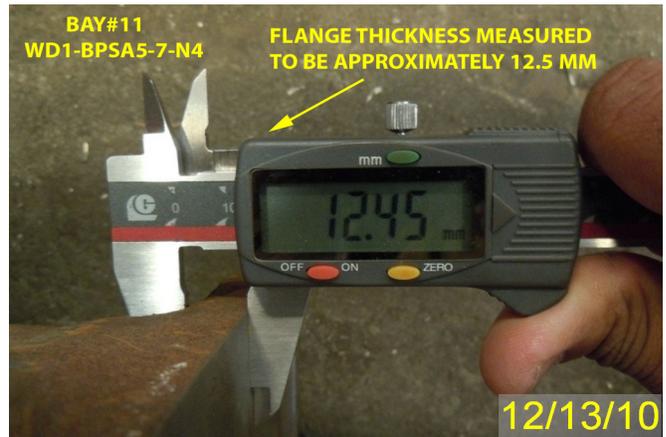
- Two (2) I-beam PL 16 mm flange thicknesses observed to be out of tolerance:

1. WD1-BPSA5-7-N1 – measured thickness is 12.78 mm.

2. WD1-BPSA5-7-N4 – measured thickness is 12.45 mm.

-The components are located at fabrication Bay#11.

1384 R0 (Changxing daily dated 11-30-10) – “PL 16 flanges: For PL16, thickness of 14mm minimum is acceptable”

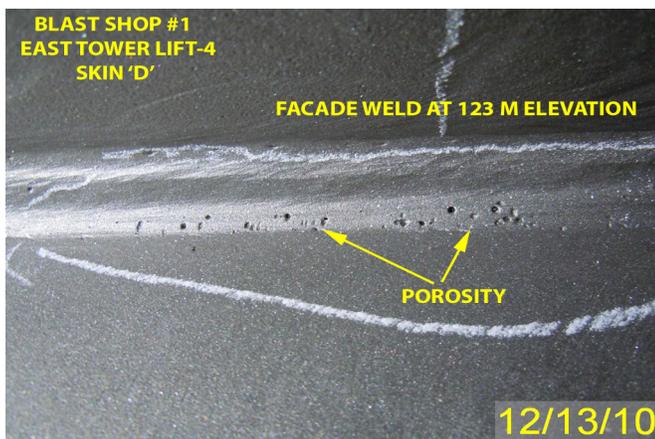
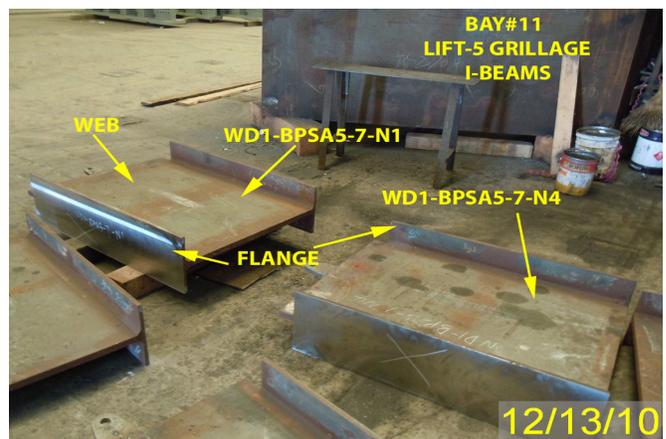
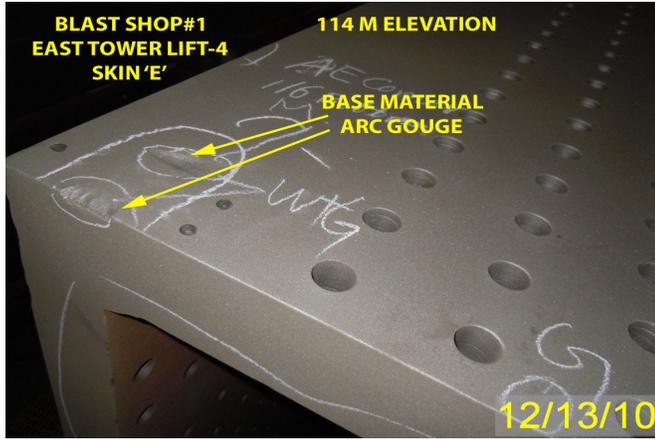
During the External post-blast visual inspection on East tower Lift-4; these Quality Assurance Inspector’s (QA)

discovered the defects required welding and Magnetic particle testing on weld and base material at the following locations:

1. Skin 'A' – Under-fill –Manhole weld at 129 M elevation.
2. Skin 'B' – Base material Arc gouge –Edge of skin 'B', close to skin 'C' at 140 M elevation.
3. Skin 'D' – Porosity –Facade weld (300 mm from bottom of the façade) at 123 M elevation.
4. Skin 'D' – Porosity –Facade weld (360 mm from top of the façade) at 123 M elevation.
5. Skin 'D' – Porosity –Facade weld (240 mm from top of the façade) at 139 M elevation.
6. Skin 'E' – Base material Arc gouge –85 mm from bottom and 80 mm from skin 'A' at 114 M elevation.
7. Skin 'E' – Base material Arc gouge –100 mm from top and 280 mm from skin 'D' at 146 M elevation.
