Contract #: 04-0120F4Cty: SF/ALA Rte: 80 PM: 13.2/13.9File #: 69.28**WELDING INSPECTION REPORT****Resident Engineer:** Siegenthaler, Peter**Address:** 333 Burma Road**City:** Oakland, CA 94607**Report No:** WIR-018964**Date Inspected:** 16-Dec-2010**Project Name:** SAS Superstructure**OSM Arrival Time:** 700**Prime Contractor:** American Bridge/Fluor Enterprises, a JV**OSM Departure Time:** 1900**Contractor:** Zhenhua Port Machinery Company, Ltd (ZPMC), Changxing Island **Location:** Shanghai, China

Bridge No: 34-0006**Component:** Tower / OBG**Summary of Items Observed:**

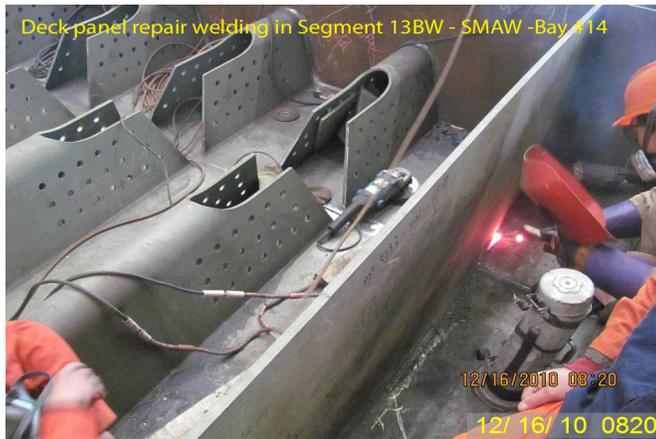
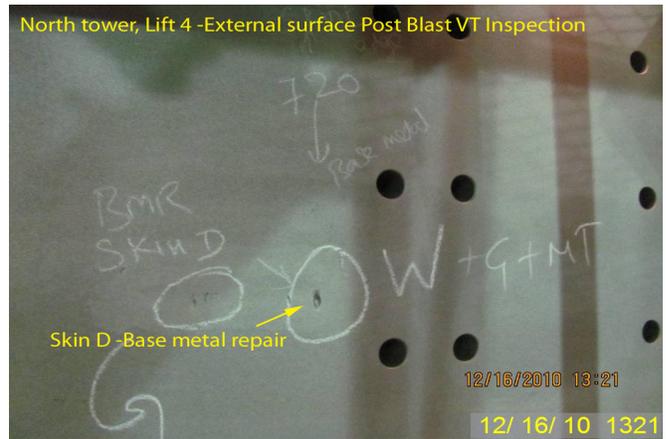
This QA inspector, Baskar Govindarajan, performed Post blast inspection of External surfaces of North tower, Lift 4 from 114 mtr. to 146 mtr. elevation. All the areas marked which requires grinding, weld repair, Grinding & MT wherever applicable in all the Skins of Tower. This inspection was carried out along with QA Inspector Mr. Sandeep Kumar (B 227), Mr. Pillai (B 286), Mr. Vikram (B 300), and Mr. Larry viars (B 252) . All the marked

points shown to ZPMC inspector Mr. Zhu Feng and ABF Inspector Mr. Wang. All the weld repair areas (2 nos) marked in weld map in detail and the same was signed by ZPMC and ABF Inspector.
