DEPARTMENT OF TRANSPORTATION

Contract #: 04-0120F4Cty: SF/ALA Rte: 80 PM: 13.2/13.9File #: 69.28**WELDING INSPECTION REPORT****Resident Engineer:** Siegenthaler, Peter**Address:** 333 Burma Road**City:** Oakland, CA 94607**Report No:** WIR-018966**Date Inspected:** 15-Dec-2010**Project Name:** SAS Superstructure**OSM Arrival Time:** 700**Prime Contractor:** American Bridge/Fluor Enterprises, a JV**OSM Departure Time:** 1900**Contractor:** Zhenhua Port Machinery Company, Ltd (ZPMC), Changxing Island **Location:** Shanghai, China**CWI Name:** Zhu Feng**CWI Present:** Yes No**Inspected CWI report:** Yes No N/A**Rod Oven in Use:** Yes No N/A**Electrode to specification:** Yes No N/A**Weld Procedures Followed:** Yes No N/A**Qualified Welders:** Yes No N/A**Verified Joint Fit-up:** Yes No N/A**Approved Drawings:** Yes No N/A**Approved WPS:** Yes No N/A**Delayed / Cancelled:** Yes No N/A**Bridge No:** 34-0006**Component:** TOWER & OBG Components**Summary of Items Observed:**

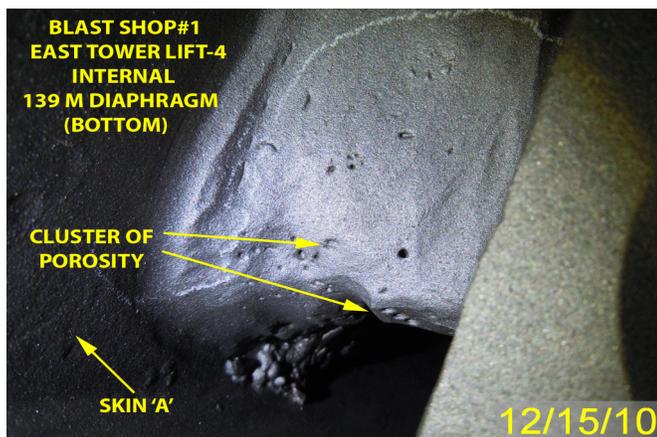
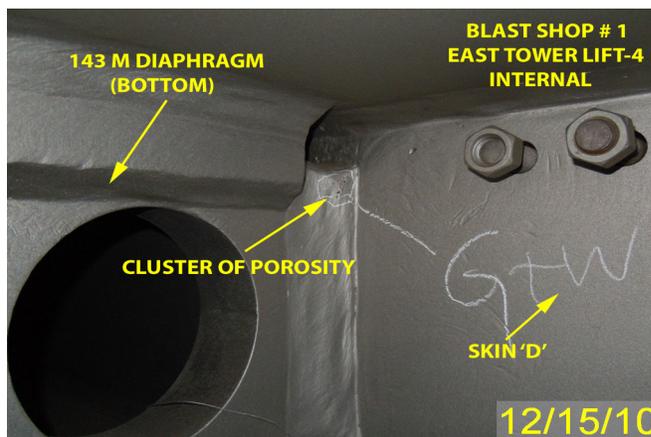
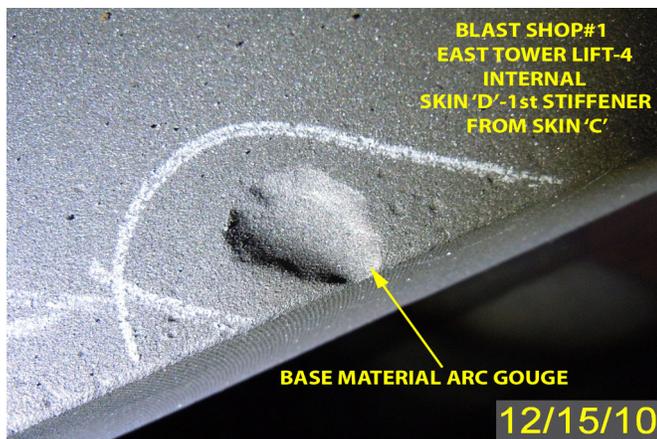
During the Internal post-blast visual inspection on East tower Lift-4 from 131 M diaphragm (TOP) to 146 M elevation, this Quality Assurance Inspector's (QA) discovered the defects required welding and Magnetic particle testing on weld and base material at the following locations:

- 1) Skin 'D' – Porosity –Diaphragm to skin weld at 143 M (bottom) elevation between 1st and 2nd stiffeners from skin 'E'.
- 2) Skin 'D' – Cluster of Porosity –Diaphragm to skin weld at 143 M (bottom) elevation between 1st and 2nd stiffeners from skin 'C'.
- 3) Skin 'E' – Arc gouge –Diaphragm to skin weld at 139 M (bottom) elevation close to A/E corner cope hole.
- 4) Skin 'A' – Cluster of porosity –Diaphragm to skin weld at 139 M (bottom) elevation close to A/E corner.
- 5) Skin 'D' – Base material arc gouge –Edge of the 1st stiffener from skin 'C' and 520 mm from at 139 M bottom diaphragm.
- 6) Skin 'A' – Base material arc gouge –Edge of the 1st stiffener from skin 'B' and 890 mm from at 139 M bottom diaphragm.
- 7) Skin 'D' – Cluster of Porosity – Diaphragm to skin weld at 135 M (top) elevation close to D/E corner.

For further information, please see the attached pictures below.
