Contract #: 04-0120F4Cty: SF/ALA Rte: 80 PM: 13.2/13.9File #: 69.28**WELDING INSPECTION REPORT****Resident Engineer:** Siegenthaler, Peter**Address:** 333 Burma Road**City:** Oakland, CA 94607**Report No:** WIR-018968**Date Inspected:** 18-Dec-2010**Project Name:** SAS Superstructure**OSM Arrival Time:** 700**Prime Contractor:** American Bridge/Fluor Enterprises, a JV**OSM Departure Time:** 1900**Contractor:** Zhenhua Port Machinery Company, Ltd (ZPMC), Changxing Island **Location:** Shanghai, China

Orthotropic Box Girder (OBG)

WELDING INSPECTION REPORT

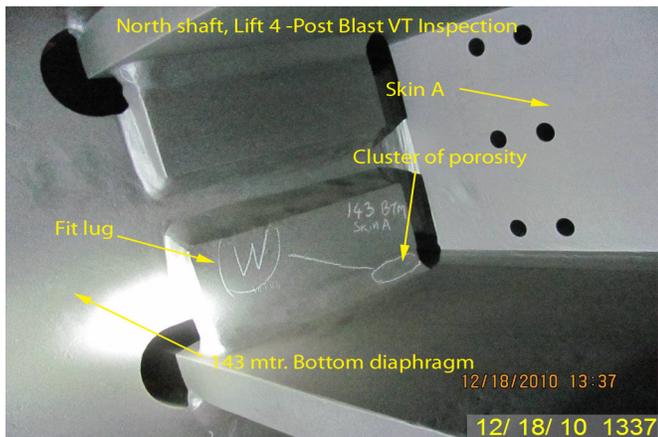
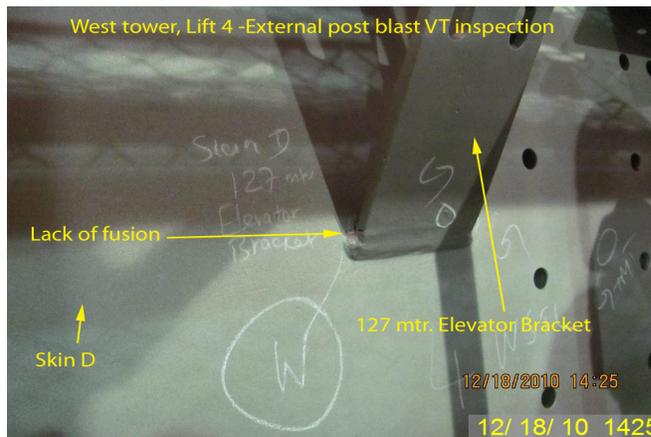
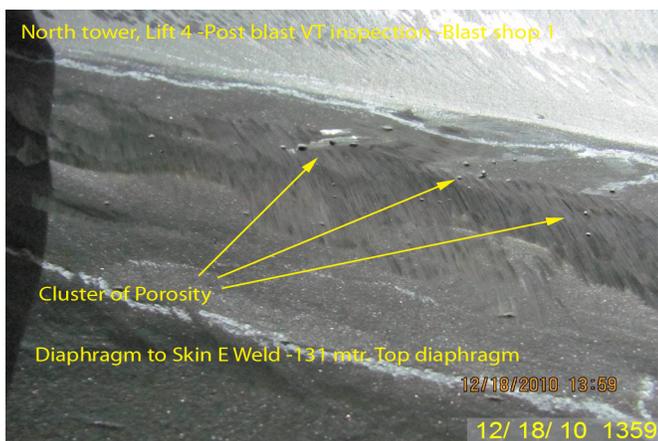
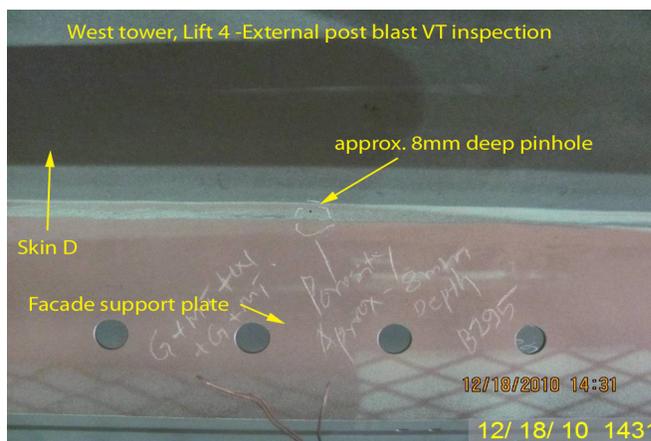
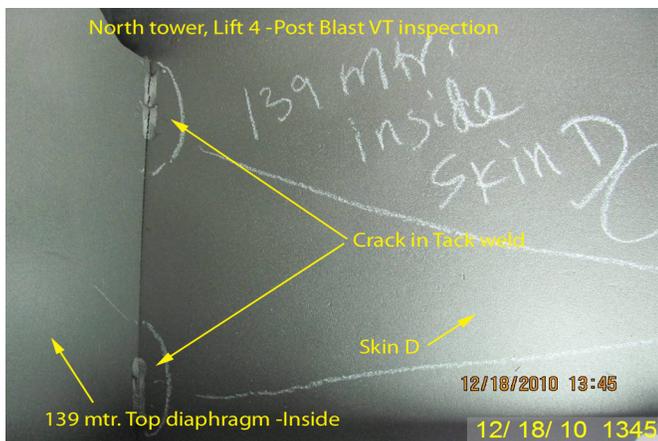
This QA inspector, Baskar Govindarajan, performed Post blast Visual inspection of External surfaces of West tower, Lift 4 from 114 mtr. to 146 mtr. elevation. All the areas marked which requires grinding, weld repair, Grinding & MT wherever applicable in all the Skins of Tower. This inspection was carried out along with QA Inspector Mr. Pillai (B 286), Mr. Vikram (B 300), and Mr. Larry viars (B 252) . All the marked points shown to ZPMC inspector Mr. Zhu Feng and ABF Inspector Mr. Yang Yi Heng. All the weld repair areas (6 nos) marked in weld map in detail and the same was signed by ZPMC and ABF Inspector.

This QA inspector, Baskar Govindarajan, performed Post blast Visual inspection of Internal surfaces of North tower, Lift 4 from 131 mtr. Top Diaphragm to 146 mtr. elevation. All the areas marked which requires grinding, weld repair, Grinding & MT wherever applicable in all the Skins of Tower. This inspection was carried out along with QA Inspector Mr. Pillai (B 286), Mr. Vikram (B 300), and Mr. Larry viars (B 252) . All the marked points shown to ZPMC inspector Mr. Zhu Feng and ABF Inspector Mr. Yang Yi Heng. All the weld repair areas (8 nos) marked in weld map in detail and the same was signed by ZPMC and ABF Inspector.
