Office of Structural Materials

Contract #: 04-0120F4Cty: SF/ALA Rte: 80 PM: 13.2/13.9File #: 69.28**WELDING INSPECTION REPORT****Resident Engineer:** Siegenthaler, Peter**Address:** 333 Burma Road**City:** Oakland, CA 94607**Report No:** WIR-018971**Date Inspected:** 20-Dec-2010**Project Name:** SAS Superstructure**OSM Arrival Time:** 700**Prime Contractor:** American Bridge/Fluor Enterprises, a JV**OSM Departure Time:** 1900**Contractor:** Zhenhua Port Machinery Company, Ltd (ZPMC), Changxing Island **Location:** Shanghai, China

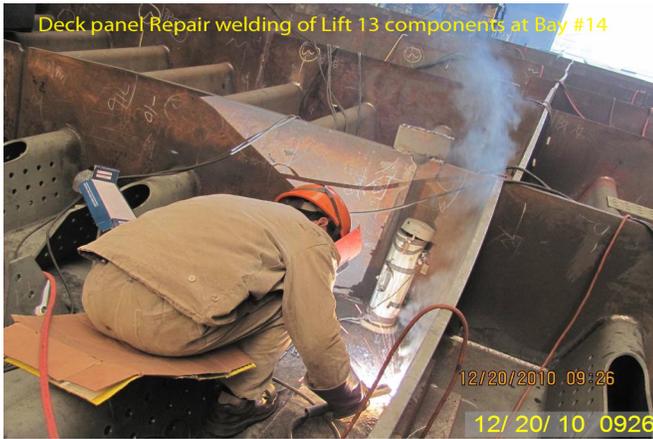
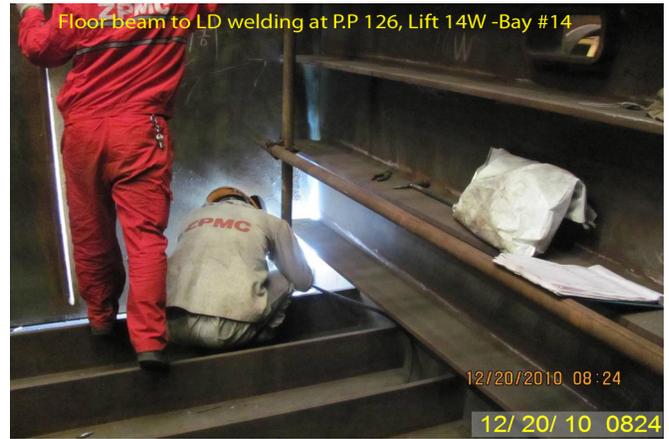
For further information see below pictures:-

Unless otherwise noted, all work observed on this date appeared to be in general compliance with the applicable contract documents.
