DEPARTMENT OF TRANSPORTATION

Contract #: 04-0120F4Cty: SF/ALA Rte: 80 PM: 13.2/13.9File #: 69.28**WELDING INSPECTION REPORT****Resident Engineer:** Siegenthaler, Peter**Address:** 333 Burma Road**City:** Oakland, CA 94607**Report No:** WIR-018979**Date Inspected:** 22-Dec-2010**Project Name:** SAS Superstructure**OSM Arrival Time:** 700**Prime Contractor:** American Bridge/Fluor Enterprises, a JV**OSM Departure Time:** 1900**Contractor:** Zhenhua Port Machinery Company, Ltd (ZPMC), Changxing Island **Location:** Shanghai, China

Bridge No: 34-0006**Component:** OBG Components**Summary of Items Observed:**

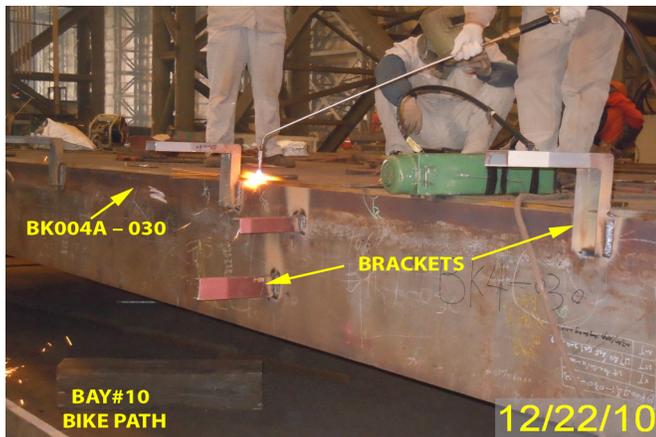
Weld joint # 17 located on Bike Path BK004A – 030 – MEP. Welder is identified as 056200. ZPMC Quality Control (QC) Inspector is identified as Li Jun. The welding variables recorded by QC appeared to comply with the WPS – B – P – 2114. (See attached photo)
