DEPARTMENT OF TRANSPORTATION

Contract #: 04-0120F4Cty: SF/ALA Rte: 80 PM: 13.2/13.9File #: 69.28**WELDING INSPECTION REPORT****Resident Engineer:** Siegenthaler, Peter**Address:** 333 Burma Road**City:** Oakland, CA 94607**Report No:** WIR-018980**Date Inspected:** 23-Dec-2010**Project Name:** SAS Superstructure**OSM Arrival Time:** 700**Prime Contractor:** American Bridge/Fluor Enterprises, a JV**OSM Departure Time:** 1900**Contractor:** Zhenhua Port Machinery Company, Ltd (ZPMC), Changxing Island **Location:** Shanghai, China

WELDING INSPECTION REPORT

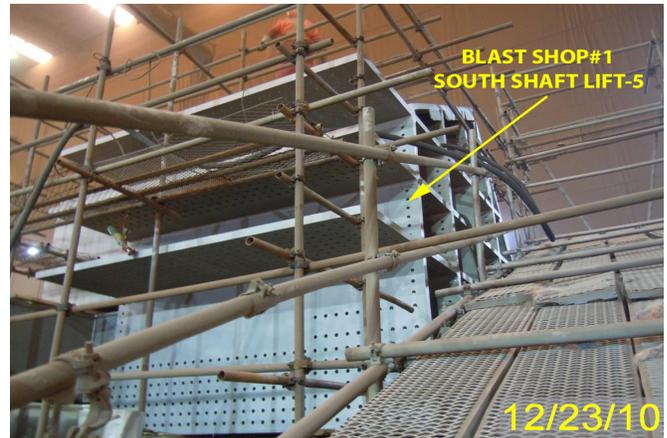
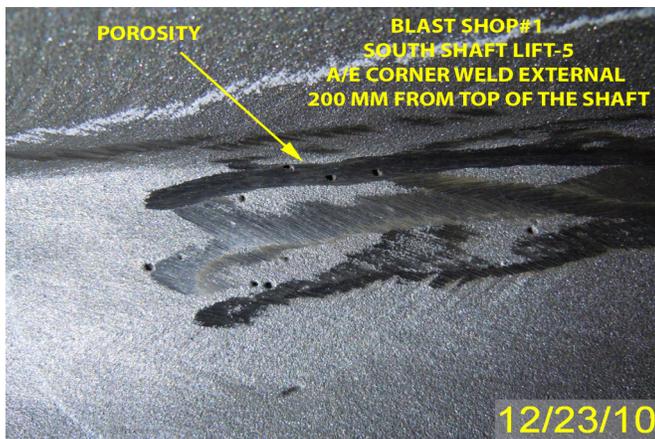
During the External & Internal post-blast visual inspection on South tower Lift-5, this Quality Assurance Inspector's (QA) discovered the defects required welding and Magnetic particle testing on weld and base material at the following locations:

- 1) External: A/E corner weld– Porosity – 200 mm from top of the shaft.
- 2) External: A/E corner weld– Porosity – 1600 mm from top of the shaft.
- 3) External: Skin 'E' (Longitudinal stiffener) – Base material arc gouge– close to the weld of 2nd stiffener and 1100 mm from bottom of the shaft.
- 4) Internal: Under fill – between 2nd longitudinal and 2nd transverse stiffeners from skin 'E', 800 mm from top of the shaft.
- 5) External: A/B corner weld – Porosity – 280 mm from top of the shaft.
