DEPARTMENT OF TRANSPORTATION

Contract #: 04-0120F4Cty: SF/ALA Rte: 80 PM: 13.2/13.9File #: 69.28**WELDING INSPECTION REPORT****Resident Engineer:** Siegenthaler, Peter**Address:** 333 Burma Road**City:** Oakland, CA 94607**Report No:** WIR-018982**Date Inspected:** 26-Dec-2010**Project Name:** SAS Superstructure**OSM Arrival Time:** 700**Prime Contractor:** American Bridge/Fluor Enterprises, a JV**OSM Departure Time:** 1900**Contractor:** Zhenhua Port Machinery Company, Ltd (ZPMC), Changxing Island **Location:** Shanghai, China

Bridge No: 34-0006**Component:** OBG**Summary of Items Observed:**

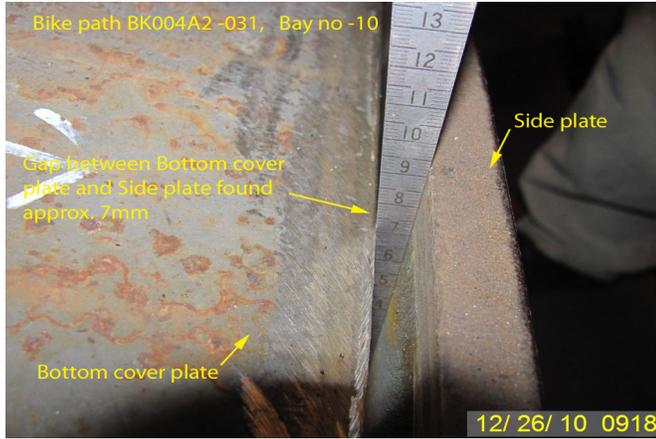
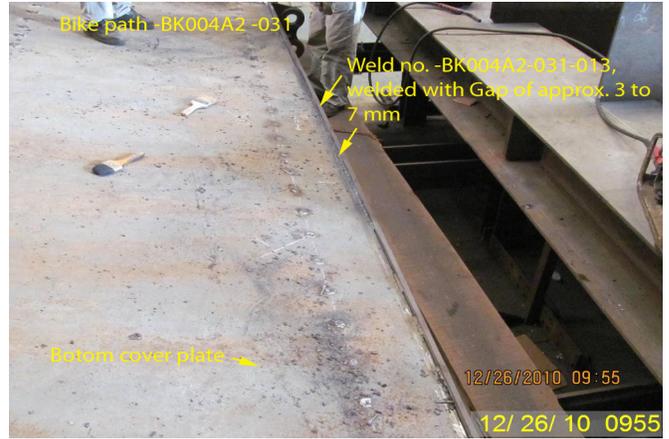
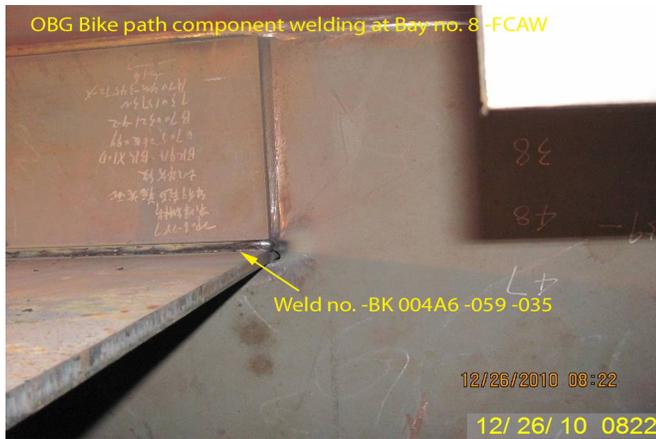
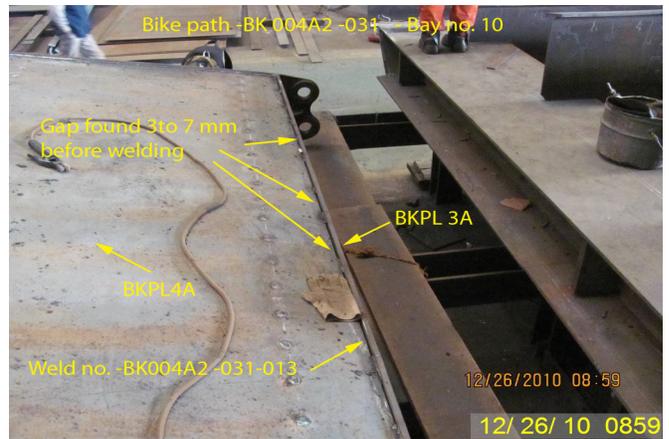
- Approx. 3 to 5 mm Gap found between Bottom cover plate and Side plate, of Bike path BK 004A2-031, before welding
- The Weld joint no. identified as BK004A2 -031 -13 and BK 004A2 -031 -21
- The area of Bike path is Bay no. 10
- 7 mm Gap observed, approx. 2000 mm from Y axis end.
- The WPS for the weld identified as WPS –B –T -2132-ESAB.

AWS D1.5 Section - 3.3.1 –“The parts to be joined by fillet welds shall be brought into as close contact as practicable. The root opening shall not exceed 5 mm [3/16 in.] except in cases involving either shapes or plates 75 mm [3 in.] or greater in thickness if, after straightening and in assembly, the root opening cannot be closed sufficiently to meet this tolerance.”
