DEPARTMENT OF TRANSPORTATION

Contract #: 04-0120F4Cty: SF/ALA Rte: 80 PM: 13.2/13.9File #: 1.28**WELDING INSPECTION REPORT****Resident Engineer:** Siegenthaler, Peter**Address:** 333 Burma Road**City:** Oakland, CA 94607**Report No:** WIR-018988**Date Inspected:** 28-Dec-2010**Project Name:** SAS Superstructure**OSM Arrival Time:** 1000**Prime Contractor:** American Bridge/Fluor Enterprises, a JV**OSM Departure Time:** 1830**Contractor:** American Bridge/Fluor Enterprises, a JV**Location:** Job Site

WELDING INSPECTION REPORT

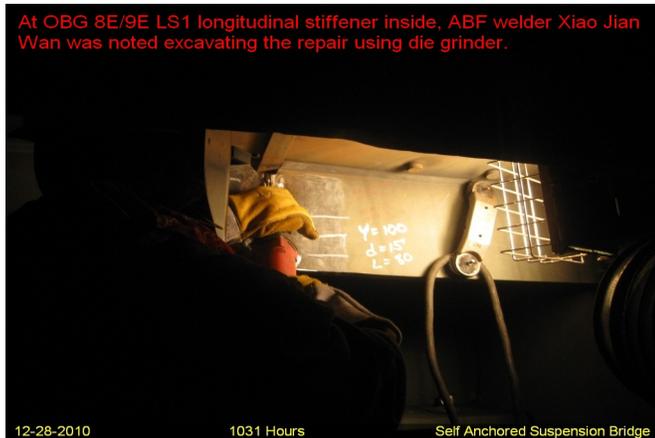
At OBG 8E/9E LS1 longitudinal stiffener inside, QA randomly observed ABF/JV qualified welder Xiao Jian Wan ID #9677 perform CJP groove welding repair. The welder was observed welding in the 3G (vertical) position utilizing Shielded Metal Arc Welding (SMAW) with 1/8" diameter E9018H4R electrode implementing welding procedure ABF-WPS-D15-1002-Repairs. The repair which was located at Y-dimension 0mm and having excavation profile of 80mm long x 30mm wide x 22mm deep was preheated to more than 200 degree Fahrenheit using propane gas torch prior welding. During the shift, ABF QC John Pagliero was noted monitoring the welder. Prior welding, ABF QC John Pagliero was also observed performing Magnetic Particle Testing (MT). Repair welding at this location was completed at the end of the shift.

At OBG 8E/9E LS1 longitudinal stiffener inside, ABF welder Xiao Jian Wan was noted excavating the repair using die grinder.

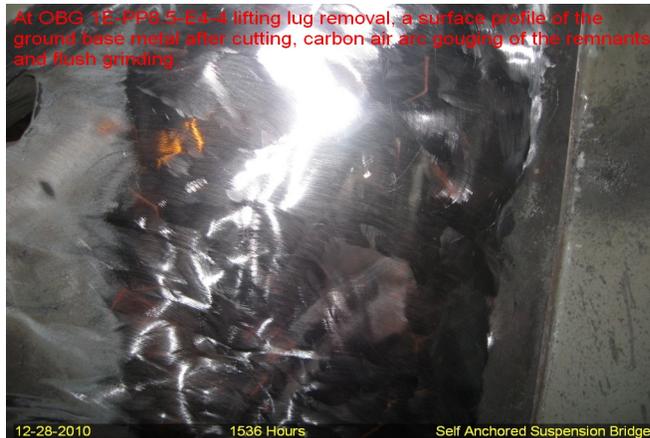
At the following locations, this QA performed Visual Test (VT) and Magnetic Particle Testing (MT) on the completed lifting lug removal. ABF personnel have used oxy-acetylene cutting torch to cut the lifting lugs to small pieces then used carbon air arc gouging to cut the small pieces remnants and flush ground the surface using a flapper disc. ABF QC Mike Johnson and William Sherwood have performed their VT and MT and then called QA for the verification. The results of the VT and MT were deemed satisfactory and in compliance to the code.

At OBG 1E-PP0.5-E4-4 lifting lug removal, a surface profile of the ground base metal after cutting, carbon arc gouging of the remnants and flush grinding.

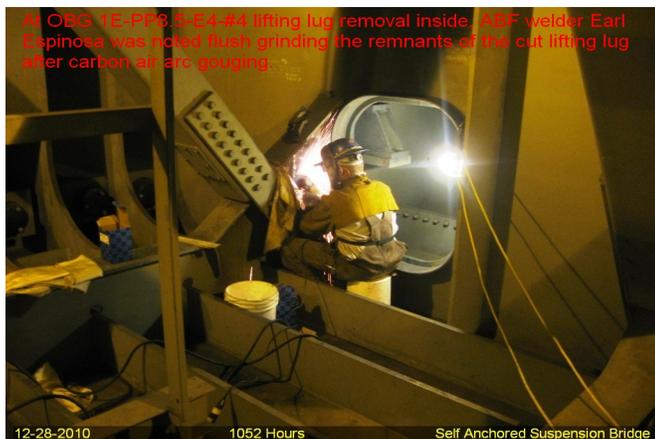
At OBG 1E-PP0.5-E4-4 lifting lug removal inside, ABF welder Earl Espinosa was noted flush grinding the remnants of the cut lifting lug after carbon arc gouging.

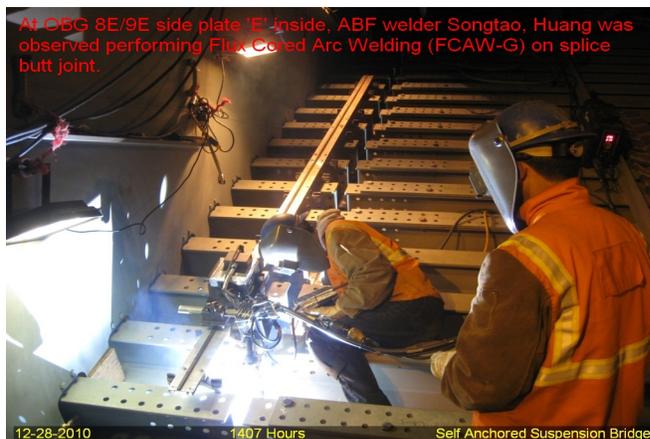
At OBG 8E/9E side plate 'C2' (5277mm to 9355mm) inside, QA randomly observed ABF/JV qualified welder Sungtao, Huang ID # 3794 continuing to perform CJP groove (splice) welding fill pass on the splice butt joint. The

At OBG 8E/9E side plate 1E inside, ABF welder Songtao, Huang was observed performing Flux Cored Arc Welding (FCAW-G) on splice butt joint.
