DEPARTMENT OF TRANSPORTATION

Contract #: 04-0120F4Cty: SF/ALA Rte: 80 PM: 13.2/13.9File #: 69.28**WELDING INSPECTION REPORT****Resident Engineer:** Siegenthaler, Peter**Address:** 333 Burma Road**City:** Oakland, CA 94607**Report No:** WIR-019007**Date Inspected:** 30-Dec-2010**Project Name:** SAS Superstructure**OSM Arrival Time:** 700**Prime Contractor:** American Bridge/Fluor Enterprises, a JV**OSM Departure Time:** 1900**Contractor:** Zhenhua Port Machinery Company, Ltd (ZPMC), Changxing Island **Location:** Shanghai, China**CWI Name:** Liu Hua Jie**CWI Present:** Yes No**Inspected CWI report:** Yes No N/A**Rod Oven in Use:** Yes No N/A**Electrode to specification:** Yes No N/A**Weld Procedures Followed:** Yes No N/A**Qualified Welders:** Yes No N/A**Verified Joint Fit-up:** Yes No N/A**Approved Drawings:** Yes No N/A**Approved WPS:** Yes No N/A**Delayed / Cancelled:** Yes No N/A**Bridge No:** 34-0006**Component:** OBG COMPONENT**Summary of Items Observed:**

WELDING INSPECTION REPORT

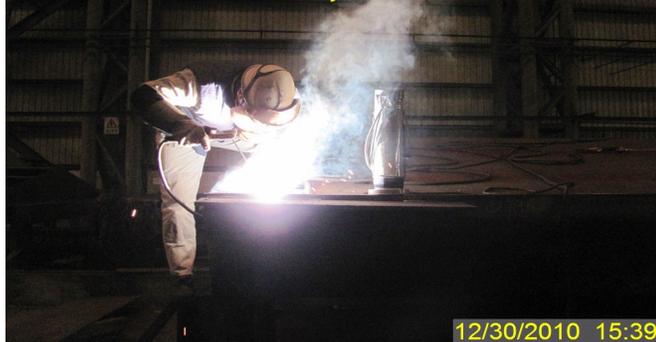
SMAW in the 1G position for the OBG bike path, weld No.BK004ASD1-003-022. The welder is identified as #040655. ZPMC QC is identified as Mr. Yu Dong Ping. The welding variables recorded by QC appear to comply with WPS-B-P-2211-Tc-U4b.

ZPMC personnel performing SMAW for weld joint BK004-ASD1-003-022 at 1G position on Bike path at bay#11

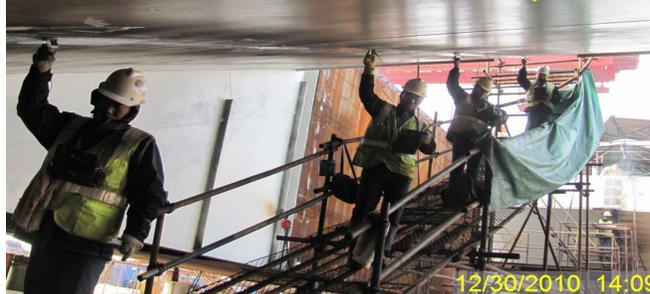
The ABF QA inspector performed D-Scan Ultrasonic Testing for splice joint joining between side plate to side plate at crossbeam side on segment 12AE to 12BE at trial assembly area

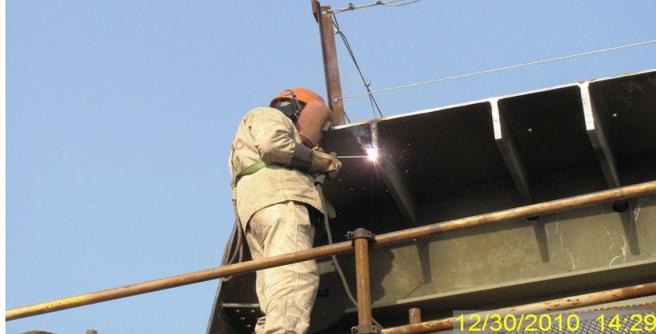
SMAW in the 3G position for the OBG Segment 12AE for Stiffener RS3004A buttering weld. The welder is identified as #044515. ZPMC QC is identified as Mr. Wang Li Yang. The welding variables recorded by QC appear to comply with WPS-345-SMAW-3G(3F)-FCM-REPAIR-1. The repair report is identified as WR19617.

ZPMC personnel performing SMAW for buttering weld on stiffener RS3004A at 3G position on segment 12AE

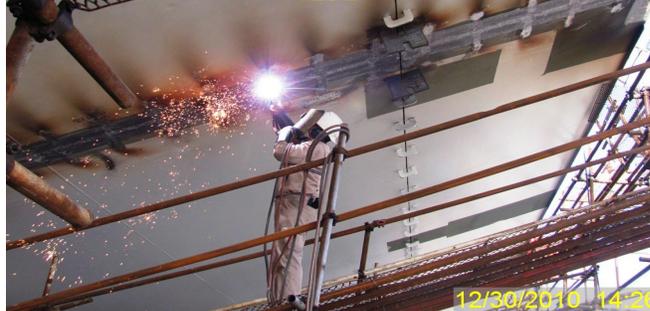
ZPMC performing Carbon Arc Back Chouging for UT repair splice joint joining between Side plate to side plate at bikepath side on Segment 12AE to 12BE
