**DEPARTMENT OF TRANSPORTATION**

Contract #: 04-0120F4Cty: SF/ALA Rte: 80 PM: 13.2/13.9File #: 69.28**WELDING INSPECTION REPORT****Resident Engineer:** Siegenthaler, Peter**Address:** 333 Burma Road**City:** Oakland, CA 94607**Report No:** WIR-019014**Date Inspected:** 08-Dec-2010**Project Name:** SAS Superstructure**OSM Arrival Time:** 700**Prime Contractor:** American Bridge/Fluor Enterprises, a JV**OSM Departure Time:** 1900**Contractor:** Zhenhua Port Machinery Company, Ltd (ZPMC), Changxing Island **Location:** Shanghai, China**CWI Name:** Lv Li Qing**CWI Present:** Yes No**Inspected CWI report:** Yes No N/A**Rod Oven in Use:** Yes No N/A**Electrode to specification:** Yes No N/A**Weld Procedures Followed:** Yes No N/A**Qualified Welders:** Yes No N/A**Verified Joint Fit-up:** Yes No N/A**Approved Drawings:** Yes No N/A**Approved WPS:** Yes No N/A**Delayed / Cancelled:** Yes No N/A**Bridge No:** 34-0006**Component:** OBG**Summary of Items Observed:**

**ULTRASONIC TESTING****OBG SEGMENT 13CW**

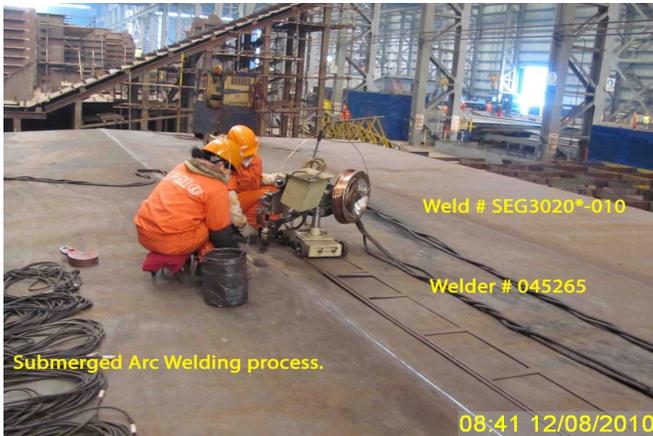
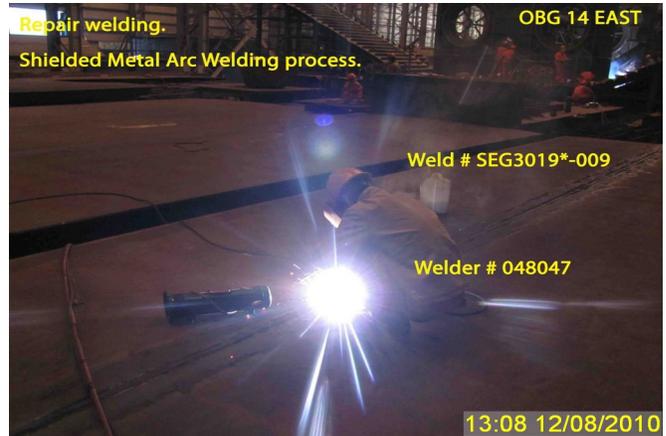
Unless otherwise noted, all work observed on this date appeared to generally comply with applicable contract documents.
