Quality Assurance and Source Inspection

Contract #: 04-0120F4Cty: SF/ALA Rte: 80 PM: 13.2/13.9File #: 1.28**WELDING INSPECTION REPORT****Resident Engineer:** Siegenthaler, Peter**Address:** 333 Burma Road**City:** Oakland, CA 94607**Report No:** WIR-019037**Date Inspected:** 03-Jan-2011**Project Name:** SAS Superstructure**OSM Arrival Time:** 900**Prime Contractor:** American Bridge/Fluor Enterprises, a JV**OSM Departure Time:** 1730**Contractor:** American Bridge/Fluor Enterprises, a JV**Location:** Jobsite**CWI Name:** See below**CWI Present:** Yes No**Inspected CWI report:** Yes No N/A**Rod Oven in Use:** Yes No N/A**Electrode to specification:** Yes No N/A**Weld Procedures Followed:** Yes No N/A**Qualified Welders:** Yes No N/A**Verified Joint Fit-up:** Yes No N/A**Approved Drawings:** Yes No N/A**Approved WPS:** Yes No N/A**Delayed / Cancelled:** Yes No N/A**Bridge No:** 34-0006**Component:** SAS OBG**Summary of Items Observed:**

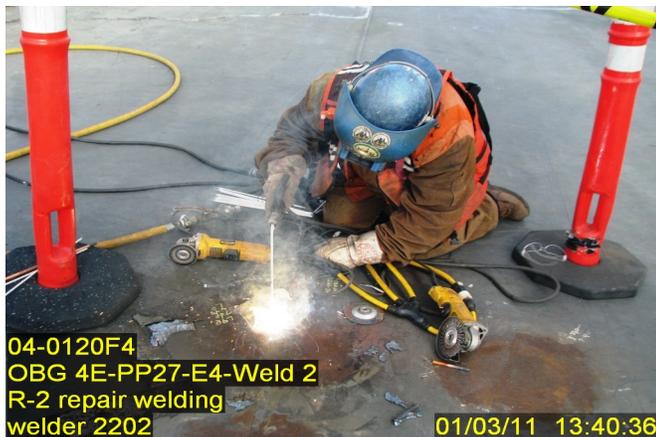
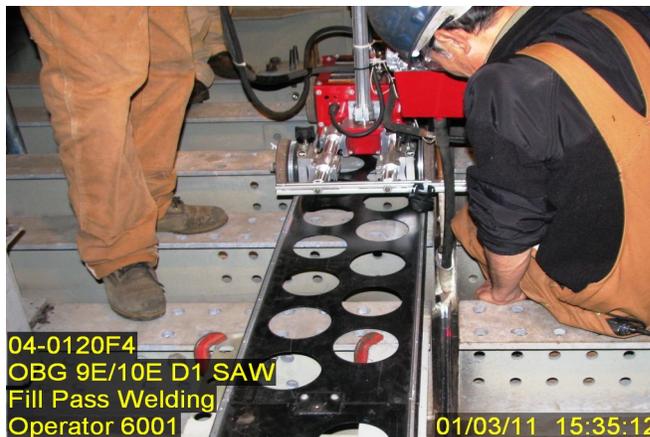
- 1). OBG Field Splice 9E/10E Weld ID: D1 & D2, Face A (SAW)

The QAI periodically observed AB/F approved welder James Zhen (ID 6001) performing welding of the root and fill passes on weld ID: D1 & D2 per the Submerged Arc Welding (SAW) process in the 1G (flat) position. See photo below. The QAI observed QC Inspectors John Pagliero and Fred Von Hoff were present to monitor the progress and verify that the welding parameters were within the limits established by the approved Welding Procedure Specification (WPS) identified as ABF-WPS-D1.5-4042B-1. The QAI observed that the work at this location was in process and appeared to be in general compliance with contract documents.
