Contract #: 04-0120F4Cty: SF/ALA Rte: 80 PM: 13.2/13.9File #: 69.28**WELDING INSPECTION REPORT****Resident Engineer:** Siegenthaler, Peter**Address:** 333 Burma Road**City:** Oakland, CA 94607**Report No:** WIR-019052**Date Inspected:** 31-Dec-2010**Project Name:** SAS Superstructure**OSM Arrival Time:** 700**Prime Contractor:** American Bridge/Fluor Enterprises, a JV**OSM Departure Time:** 1900**Contractor:** Zhenhua Port Machinery Company, Ltd (ZPMC), Changxing Island **Location:** Shanghai, China**CWI Name:** Li Yang**CWI Present:** Yes No**Inspected CWI report:** Yes No N/A**Rod Oven in Use:** Yes No N/A**Electrode to specification:** Yes No N/A**Weld Procedures Followed:** Yes No N/A**Qualified Welders:** Yes No N/A**Verified Joint Fit-up:** Yes No N/A**Approved Drawings:** Yes No N/A**Approved WPS:** Yes No N/A**Delayed / Cancelled:** Yes No N/A**Bridge No:** 34-0006**Component:** OBG Segment**Summary of Items Observed:**

OBG # TRIAL ASSEMBLY YARD (11DE)

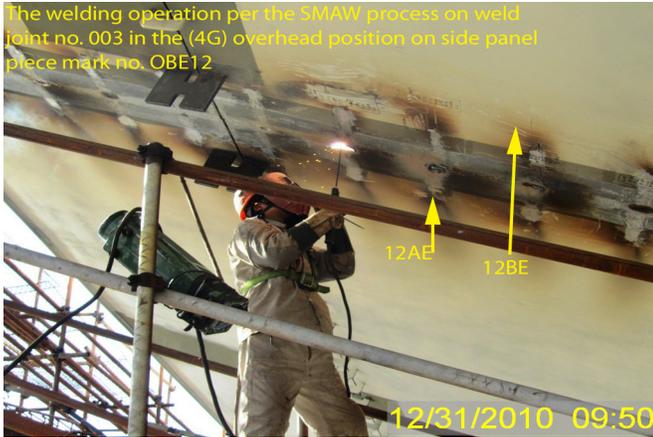
For additional information please reference the pictures below:
