**DEPARTMENT OF TRANSPORTATION**

Contract #: 04-0120F4Cty: SF/ALA Rte: 80 PM: 13.2/13.9File #: 69.28**WELDING INSPECTION REPORT****Resident Engineer:** Siegenthaler, Peter**Address:** 333 Burma Road**City:** Oakland, CA 94607**Report No:** WIR-019053**Date Inspected:** 01-Jan-2011**Project Name:** SAS Superstructure**OSM Arrival Time:** 700**Prime Contractor:** American Bridge/Fluor Enterprises, a JV**OSM Departure Time:** 1900**Contractor:** Zhenhua Port Machinery Company, Ltd (ZPMC), Changxing Island **Location:** Shanghai, China**CWI Name:** Li Yang**CWI Present:** Yes No**Inspected CWI report:** Yes No N/A**Rod Oven in Use:** Yes No N/A**Electrode to specification:** Yes No N/A**Weld Procedures Followed:** Yes No N/A**Qualified Welders:** Yes No N/A**Verified Joint Fit-up:** Yes No N/A**Approved Drawings:** Yes No N/A**Approved WPS:** Yes No N/A**Delayed / Cancelled:** Yes No N/A**Bridge No:** 34-0006**Component:** OBG Segment**Summary of Items Observed:**

## WELDING INSPECTION REPORT

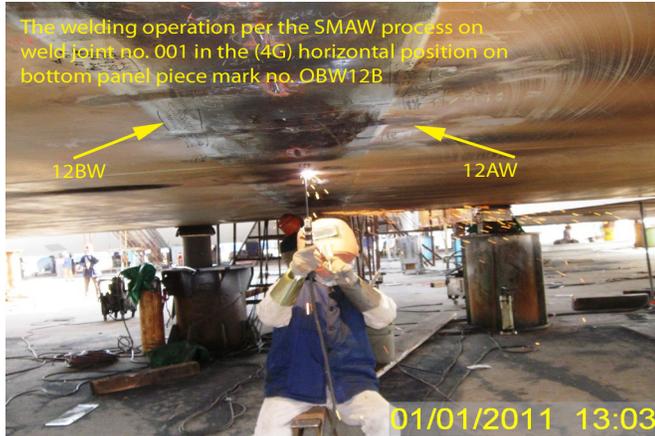
For additional information please reference the pictures below:
