Contract #: 04-0120F4Cty: SF/ALA Rte: 80 PM: 13.2/13.9File #: 69.28**WELDING INSPECTION REPORT****Resident Engineer:** Siegenthaler, Peter**Address:** 333 Burma Road**City:** Oakland, CA 94607**Report No:** WIR-019056**Date Inspected:** 03-Jan-2011**Project Name:** SAS Superstructure**OSM Arrival Time:** 700**Prime Contractor:** American Bridge/Fluor Enterprises, a JV**OSM Departure Time:** 1900**Contractor:** Zhenhua Port Machinery Company, Ltd (ZPMC), Changxing Island **Location:** Shanghai, China**CWI Name:** Li Yang**CWI Present:** Yes No**Inspected CWI report:** Yes No N/A**Rod Oven in Use:** Yes No N/A**Electrode to specification:** Yes No N/A**Weld Procedures Followed:** Yes No N/A**Qualified Welders:** Yes No N/A**Verified Joint Fit-up:** Yes No N/A**Approved Drawings:** Yes No N/A**Approved WPS:** Yes No N/A**Delayed / Cancelled:** Yes No N/A**Bridge No:** 34-0006**Component:** OBG Segment**Summary of Items Observed:**

OBG # TRIAL ASSEMBLY YARD (12AE and 12BE)

## WELDING INSPECTION REPORT

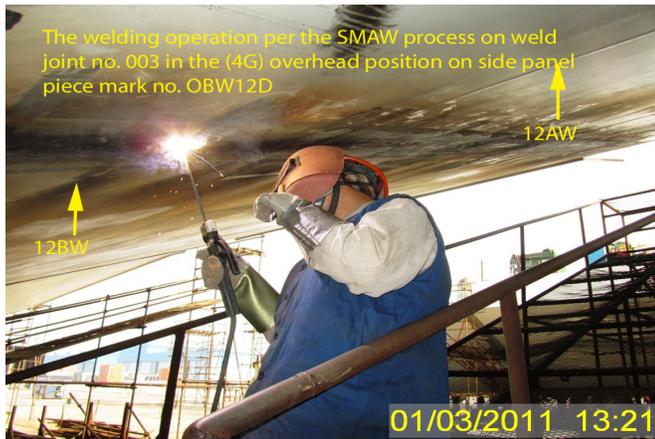
For additional information please reference the pictures below:

The QA Inspector observed the welding operation per the SMAW process on weld joint no. 001 in the (3G) vertical position on side panel piece mark no. OBW12D. The location was the complete joint penetration groove weld joining the side panel of segment 12AW and 12BW at work point W1 to W3. The welder ID was 040656. The welding was performed against welding repair report B-WR19713. The ZPMC CWI was identified as Li Yang. The welding variables recorded by QC appeared to comply with the WPS-345-SMAW-3G
