Contract #: 04-0120F4Cty: SF/ALA Rte: 80 PM: 13.2/13.9File #: 69.28**WELDING INSPECTION REPORT****Resident Engineer:** Siegenthaler, Peter**Address:** 333 Burma Road**City:** Oakland, CA 94607**Report No:** WIR-019066**Date Inspected:** 27-Dec-2010**Project Name:** SAS Superstructure**OSM Arrival Time:** 700**Prime Contractor:** American Bridge/Fluor Enterprises, a JV**OSM Departure Time:** 1900**Contractor:** Zhenhua Port Machinery Company, Ltd (ZPMC), Changxing Island **Location:** Shanghai, China

Bridge No: 34-0006**Component:** Orthotropic Box Girder (OBG)**Summary of Items Observed:**

BAY- 7-Cross beam (CB)-CB19 (Segment tagging).

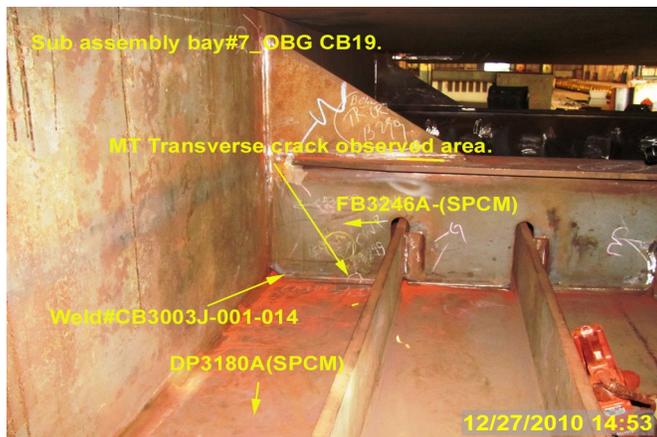
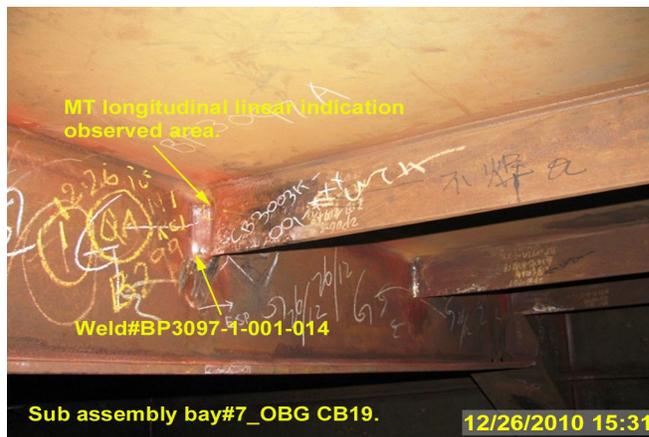
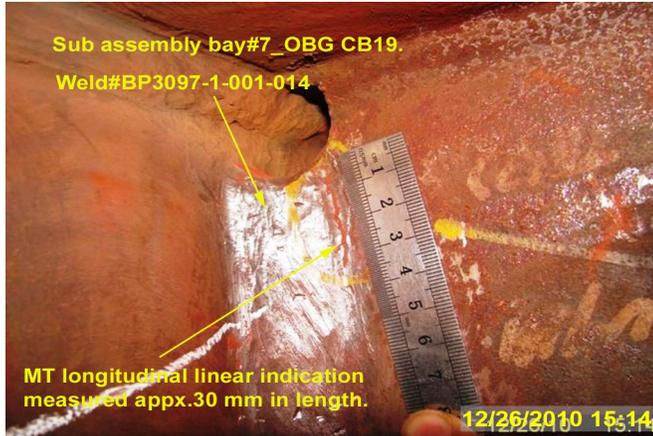
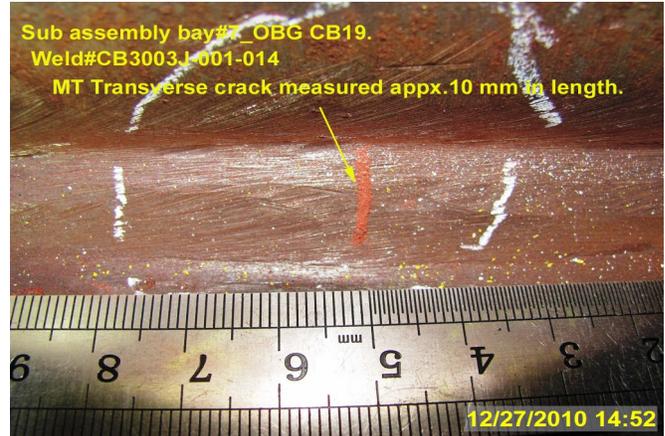
During QA MT review of welds located on OBG CB19, this QA observed One (1) Transverse crack measuring approximately 10 mm in length. The weld is identified as: CB3003J-001-014. The “Y” location is approximately 250 mm from East end cope hole. The weld is a fillet weld joining to floor beam diaphragm (FB3246A-SPCM) to deck plate (DP3180A-SPCM). One (1) Longitudinal Linear indication on weld toe measuring approximately 30 mm in length. The weld is identified as: BP3097-1-001-014. The “Y” location is approximately 5 mm from bottom cope hole. The weld is a CJP weld joining stiffener plate to bottom plate (BP3097A). Four (4) Transverse cracks measuring approximately 3~5 mm in length. The weld is identified as: CB3003A-019-009. The “Y” locations are approximately 450 mm, 995 mm, 1040mm and 1053 mm respectively from south end. The weld is a fillet weld joining intermediate plate (FB3240A-SPCM) to deck plate (DP3180A-SPCM). One (1) Longitudinal Linear indication on base metal near to weld toe measuring approximately 8 mm in length. The weld is identified as: CB3003K-002-125. The “Y” locations are approximately 10 mm and 3 mm from West end and weld toe respectively. The weld is a Complete Joint Penetration (CJP) weld joining floor beam diaphragm (FB3245A-SPCM) to plate (X4254E-SPCM). One (1) Transverse crack measuring approximately 8 mm in length. The weld is identified as: CB3003J-002-190. The “Y” location is approximately 0 mm from East end. The weld is a Complete Joint Penetration (CJP) weld joining floor beam diaphragm (FB3245A-SPCM) to plate (X4254E). All the material above is designated as Seismic Performance Critical Members (SPCM).

This QA generated an incident report for the above issues, for further information see the incident report and the attached photos.
