**DEPARTMENT OF TRANSPORTATION**

Contract #: 04-0120F4Cty: SF/ALA Rte: 80 PM: 13.2/13.9File #: 99.28**WELDING INSPECTION REPORT****Resident Engineer:** Siegenthaler, Peter**Address:** 333 Burma Road**City:** Oakland, CA 94607**Report No:** WIR-019072**Date Inspected:** 08-Jan-2011**Project Name:** SAS Superstructure**OSM Arrival Time:** 700**Prime Contractor:** American Bridge/Fluor Enterprises, a JV**OSM Departure Time:** 1900**Contractor:** Zhenhua Port Machinery Company, Ltd (ZPMC) Chanxing Island**Location:** Shanghai, China**CWI Name:** Mr. Qui Wen**CWI Present:** Yes No**Inspected CWI report:** Yes No N/A**Rod Oven in Use:** Yes No N/A**Electrode to specification:** Yes No N/A**Weld Procedures Followed:** Yes No N/A**Qualified Welders:** Yes No N/A**Verified Joint Fit-up:** Yes No N/A**Approved Drawings:** Yes No N/A**Approved WPS:** Yes No N/A**Delayed / Cancelled:** Yes No N/A**Bridge No:** 34-0006**Component:** OBG Segment**Summary of Items Observed:**

## WELDING INSPECTION REPORT

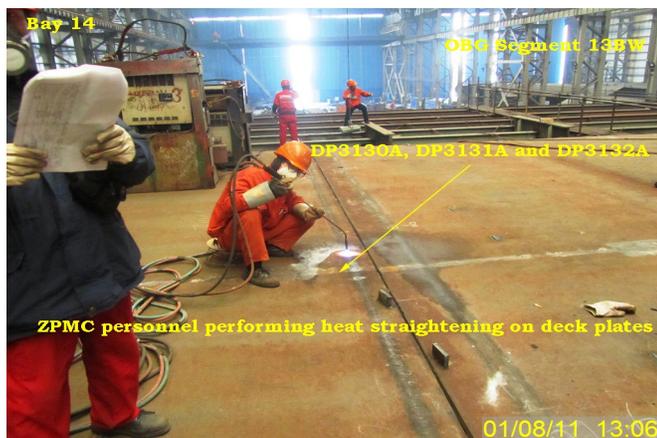
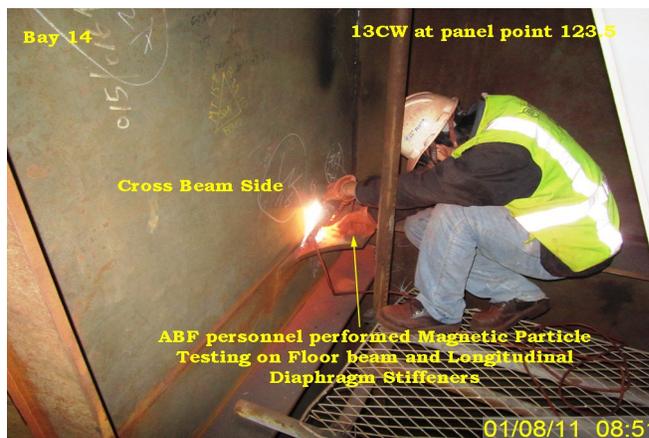
ZPMC personnel performing heat straightening on deck plate of OBG Segment 13BW member identified as DP3130A, DP3131A and DP3132A. Distortion appeared to be caused by mishandling of the welding/material. ZPMC Quality Control (QC) inspector identified as Mr. Li Ming Yang was present to monitor the heat straightening process. The heat straightening appeared to comply with HSR1 (B) number 10040. See the attached picture.
