Contract #: 04-0120F4Cty: SF/ALA Rte: 80 PM: 13.2/13.9File #: 99.28**WELDING INSPECTION REPORT****Resident Engineer:** Siegenthaler, Peter**Address:** 333 Burma Road**City:** Oakland, CA 94607**Report No:** WIR-019078**Date Inspected:** 27-Dec-2010**Project Name:** SAS Superstructure**OSM Arrival Time:** 700**Prime Contractor:** American Bridge/Fluor Enterprises, a JV**OSM Departure Time:** 1900**Contractor:** Zhenhua Port Machinery Company, Ltd (ZPMC) Chanxing Island**Location:** Shanghai, China

Bridge No: 34-0006**Component:** OBG Segment**Summary of Items Observed:**

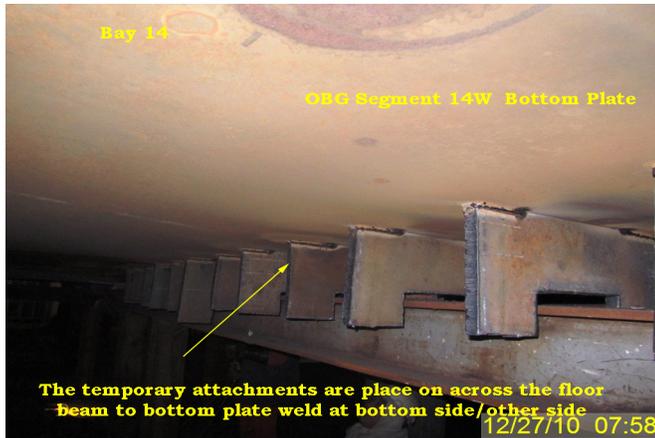
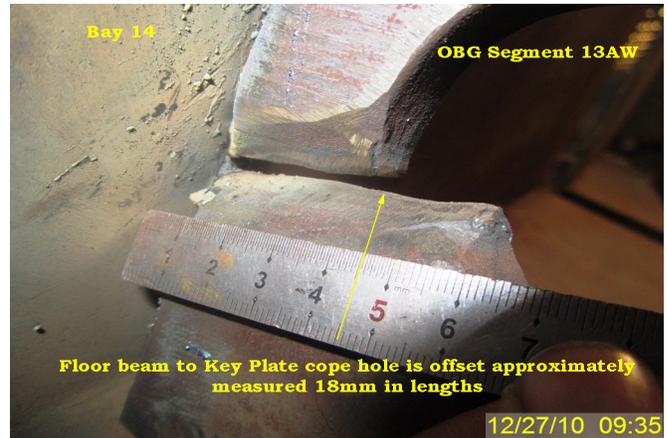
Description of Incident: During the Quality Assurance random visual inspection of welds located on OBG Segment 14W, this Quality Assurance Inspector (QA) observed ZMPC personnel performing un-approved Seismic Performance Critical Member (SPCM) Temporary attachment on the bottom plate of OBG Segment 14W without the Engineer's approval. The weld is identified as SEG3020Q-058. The temporary attachments are placed across the floor beam to bottom plate weld at bottom side/other side. The Floor Beam to Bottom Plate weld is identified as SEG3020D-052. This weld is designated as Seismic Performance Critical Member (SPCM). OBG segment 14W is located West Side of Bay 14 area. The ZPMC QC is identified as Mr. Li Ming Yang. The floor number is identified as FB3343A and Bottom Plate is identified as BP3092A. See the attached picture.

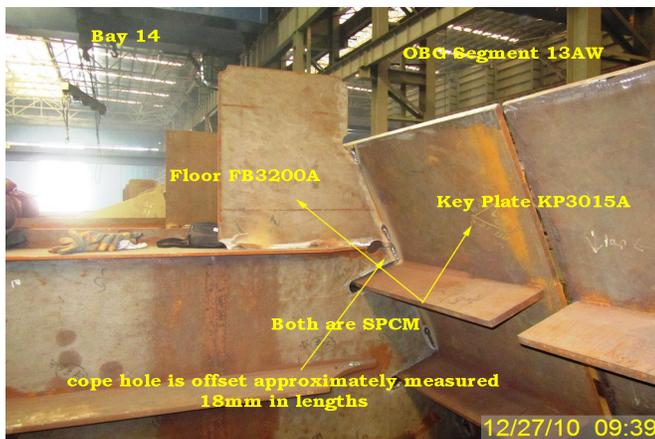
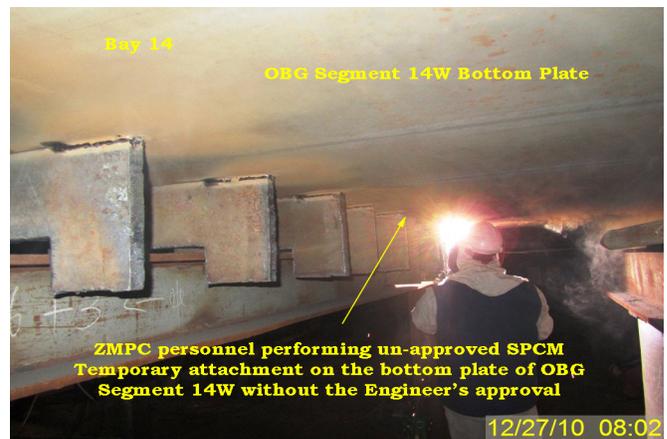
Description of Incident: During the Quality Assurance random visual inspection of welds located on Segment 13AW, this Quality Assurance Inspector (QA) observed the Floor beam to Key Plate cope hole is offset approximately measured 18mm in lengths. OBG segment 13AW is located West Side of Bay 14 area. The ZPMC QC is identified as Mr. Li Ming Yang. The floor number is identified as FB3200A and Key Plate is identified as KP3015A. See the attached picture. The Floor Beam and key Plate are identified as Seismic Performance Critical Member (SPCM). QA inform to ZPMC that prior to the repair welding, to prepare CWR and to perform offset correction comply with contract documents. See the attached picture.
