Contract #: 04-0120F4Cty: SF/ALA Rte: 80 PM: 13.2/13.9File #: 99.28**WELDING INSPECTION REPORT****Resident Engineer:** Siegenthaler, Peter**Address:** 333 Burma Road**City:** Oakland, CA 94607**Report No:** WIR-019079**Date Inspected:** 26-Dec-2010**Project Name:** SAS Superstructure**OSM Arrival Time:** 700**Prime Contractor:** American Bridge/Fluor Enterprises, a JV**OSM Departure Time:** 1900**Contractor:** Zhenhua Port Machinery Company, Ltd (ZPMC) Chanxing Island**Location:** Shanghai, China

**Bridge No:** 34-0006**Component:** OBG Segment**Summary of Items Observed:**

## WELDING INSPECTION REPORT

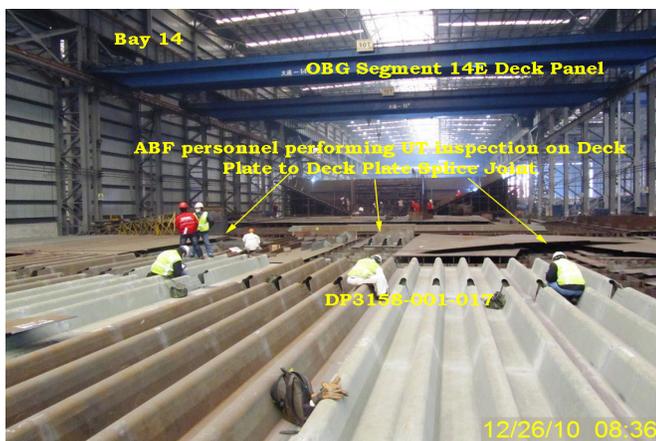
This QA inspector observed ABF personnel performed Ultrasonic Testing on deck plate to deck plate splice joint of the OBG Segment 14E and the welds are identified as DP3158-001-017, DP3158-001-021 and DP3167-001-030. See the attached picture.

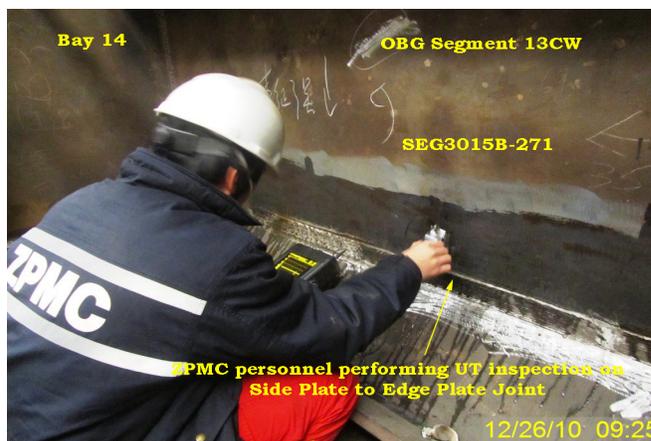
This QA inspector observed ZPMC personnel performed Ultrasonic Testing on side plate to vertical plate joint of the OBG Segment 13CW and the weld is identified as SEG3015B-271. See the attached picture.
