**DEPARTMENT OF TRANSPORTATION**

Contract #: 04-0120F4Cty: SF/ALA Rte: 80 PM: 13.2/13.9File #: 69.28**WELDING INSPECTION REPORT****Resident Engineer:** Siegenthaler, Peter**Address:** 333 Burma Road**City:** Oakland, CA 94607**Report No:** WIR-019113**Date Inspected:** 05-Jan-2011**Project Name:** SAS Superstructure**OSM Arrival Time:** 700**Prime Contractor:** American Bridge/Fluor Enterprises, a JV**OSM Departure Time:** 1900**Contractor:** Zhenhua Port Machinery Company, Ltd (ZPMC), Changxing Island **Location:** Shanghai, China**CWI Name:** Xu tao**CWI Present:** Yes No**Inspected CWI report:** Yes No N/A**Rod Oven in Use:** Yes No N/A**Electrode to specification:** Yes No N/A**Weld Procedures Followed:** Yes No N/A**Qualified Welders:** Yes No N/A**Verified Joint Fit-up:** Yes No N/A**Approved Drawings:** Yes No N/A**Approved WPS:** Yes No N/A**Delayed / Cancelled:** Yes No N/A**Bridge No:** 34-0006**Component:** OBG Components**Summary of Items Observed:**

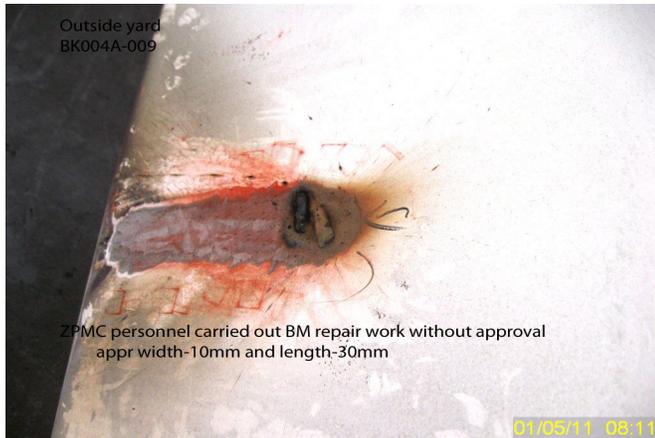
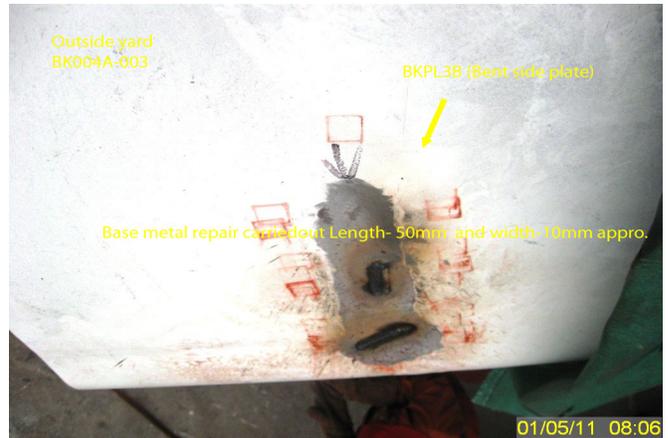
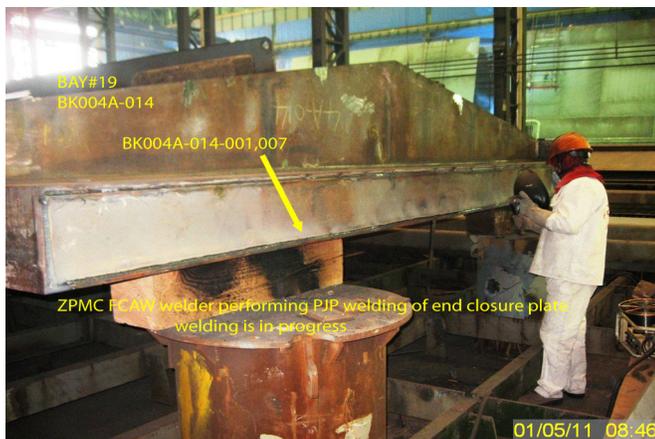
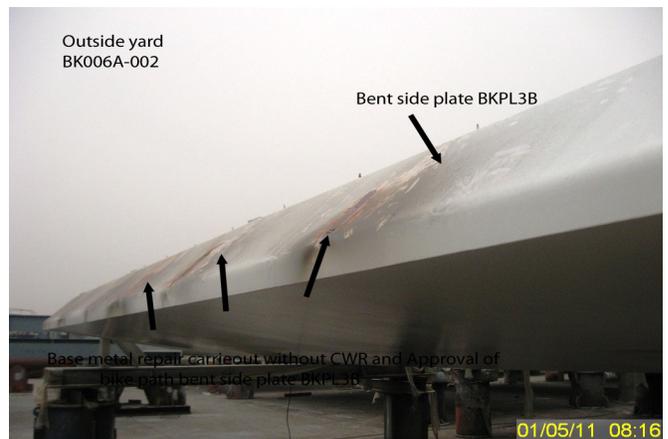
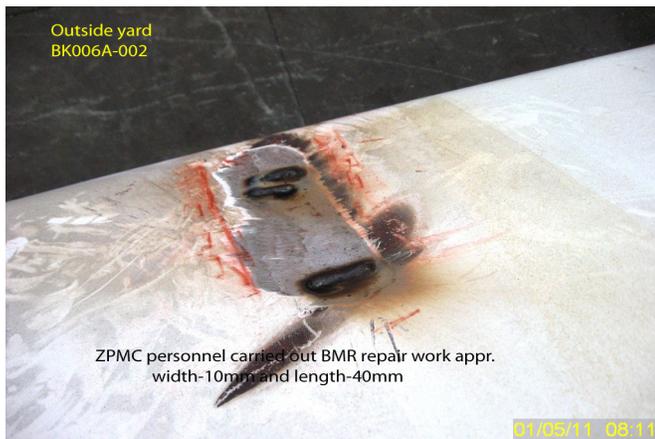
During random in-process visual inspection of OBG Bike path, Caltrans Quality Assurance (QA) Inspector discovered the following issue;

-ZPMC personnel had performed base metal repairs (BMR) without a critical weld report (CWR) or without prior approval of the engineer.

-These repairs were performed due to MT Linear Indications discovered by ABF QC MT personnel on light brackets removal areas from the side plate.

-Ten (10) different BMR repairs were located on bike paths approximately 10mm width, with lengths between 20 to 50mm.

-The bike paths are identified as; BK004A-003, BK004A-009, BK004A-004, BK004A-012 and BK006A-002
