DEPARTMENT OF TRANSPORTATION

Quality Assurance and Source Inspection

Contract #: 04-0120F4Cty: SF/ALA Rte: 80 PM: 13.2/13.9File #: 1.28**WELDING INSPECTION REPORT****Resident Engineer:** Siegenthaler, Peter**Address:** 333 Burma Road**City:** Oakland, CA 94607**Report No:** WIR-019157**Date Inspected:** 04-Jan-2011**Project Name:** SAS Superstructure**OSM Arrival Time:** 630**Prime Contractor:** American Bridge/Fluor Enterprises, a JV**OSM Departure Time:** 1500**Contractor:** American Bridge/Fluor Enterprises, a JV**Location:** Job Site**CWI Name:** See Below**CWI Present:** Yes No**Inspected CWI report:** Yes No N/A**Rod Oven in Use:** Yes No N/A**Electrode to specification:** Yes No N/A**Weld Procedures Followed:** Yes No N/A**Qualified Welders:** Yes No N/A**Verified Joint Fit-up:** Yes No N/A**Approved Drawings:** Yes No N/A**Approved WPS:** Yes No N/A**Delayed / Cancelled:** Yes No N/A**Bridge No:** 34-0006**Component:** Orthotropic Box Girders**Summary of Items Observed:**

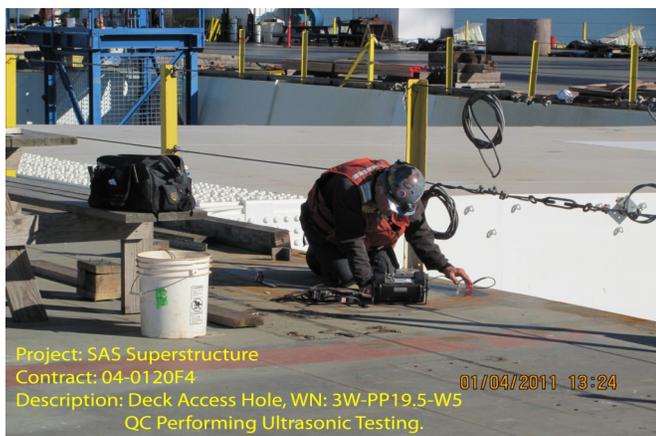
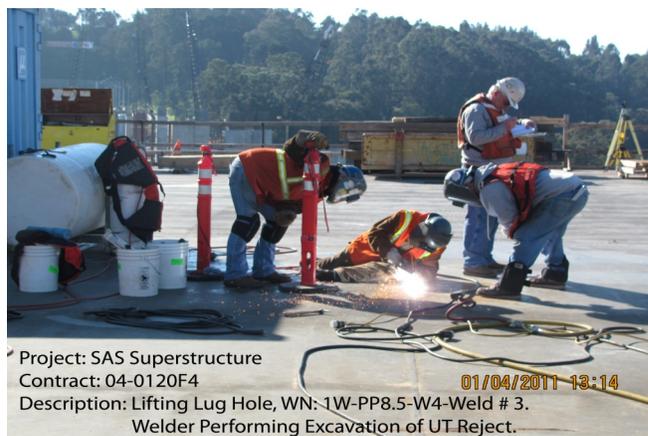
The digital photographs below illustrate some of the work observed during this scheduled shift.
