DEPARTMENT OF TRANSPORTATION

The Quality Assurance Inspector (QAI), Scott Croff, was present at the Self Anchored Span (SAS) job site to observe the scheduled fabrication and welding of components for the SFOBB project.

WELDING INSPECTION REPORT

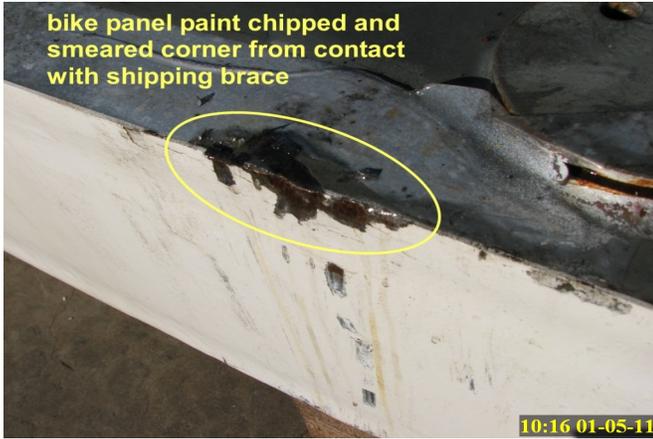
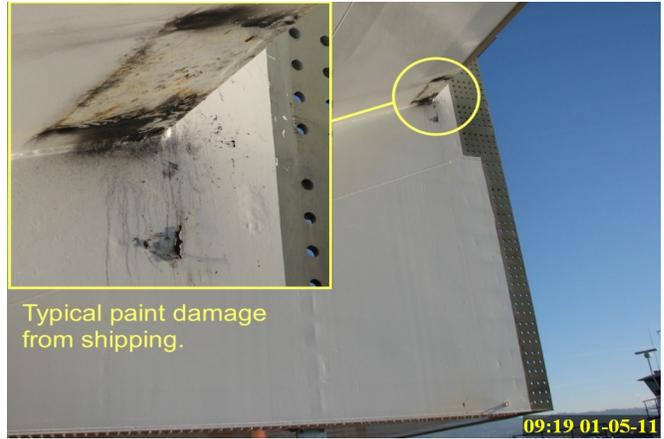
The QAI accompanied Caltrans representative Jason Wilcox and ABF representative Chuck Kanapicki in conducting the post arrival inspection of voyage 6 OBG segment 10W and bike path panels. During the inspection of these components, the QAI noted that painted surfaces have been marred from general shipping and handling. The QAI noted that on one of the bike path panels, one of the edges has been scraped from contact with a shipping support. The QAI also noted that the identification of the 4 bike path panels is by panel point location. The QAI was not able to match the identification of the bike path segments with the numbers provided on the shipping list. The panel identification is: pp9-pp11, pp13-pp15, pp17-pp19 and pp19-pp21. The QAI was informed that additional post arrival inspections of components that are part of voyage 6 will be scheduled when ready. See the attached photos.
