DEPARTMENT OF TRANSPORTATION

Quality Assurance and Source Inspection

Contract #: 04-0120F4Cty: SF/ALA Rte: 80 PM: 13.2/13.9File #: 1.28**WELDING INSPECTION REPORT****Resident Engineer:** Siegenthaler, Peter**Address:** 333 Burma Road**City:** Oakland, CA 94607**Report No:** WIR-019169**Date Inspected:** 05-Jan-2011**Project Name:** SAS Superstructure**OSM Arrival Time:** 900**Prime Contractor:** American Bridge/Fluor Enterprises, a JV**OSM Departure Time:** 1730**Contractor:** American Bridge/Fluor Enterprises, a JV**Location:** Jobsite**CWI Name:** See below**CWI Present:** Yes No**Inspected CWI report:** Yes No N/A**Rod Oven in Use:** Yes No N/A**Electrode to specification:** Yes No N/A**Weld Procedures Followed:** Yes No N/A**Qualified Welders:** Yes No N/A**Verified Joint Fit-up:** Yes No N/A**Approved Drawings:** Yes No N/A**Approved WPS:** Yes No N/A**Delayed / Cancelled:** Yes No N/A**Bridge No:** 34-0006**Component:** SAS OBG**Summary of Items Observed:**

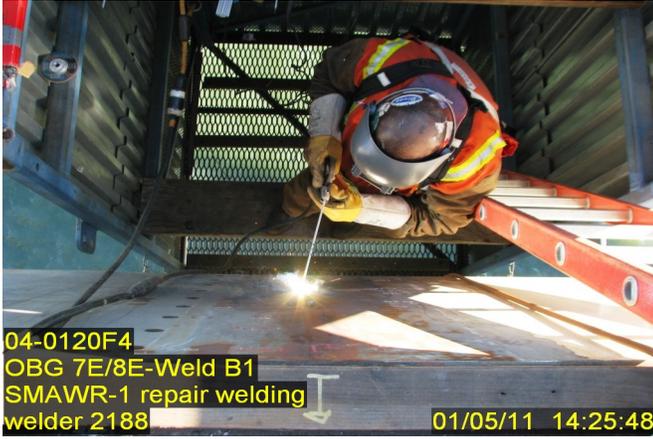
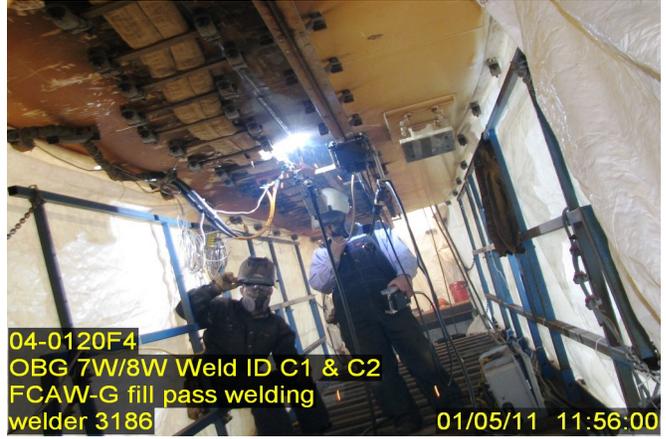
The QAI periodically observed AB/F approved welder Rory Hogan (ID 3186) assisted by AB/F approved welder Jeremy Dolman (ID 5042) performing fill and cover pass welding per the Flux Cored Arc Welding (FCAW-G) process in the 4G (overhead) position. See photo below. The QAI periodically observed QC inspector Gary Ehram was present to monitor the progress and verify that the welding parameters were within the limits established by the approved welding Procedure Specification (WPS) identified as ABF-WPS-D1.5-3110-4. The welding of cover passes was completed at this location and the work appeared to be in general compliance with contract documents.
