DEPARTMENT OF TRANSPORTATION

Contract #: 04-0120F4Cty: SF/ALA Rte: 80 PM: 13.2/13.9File #: 69.28**WELDING INSPECTION REPORT****Resident Engineer:** Siegenthaler, Peter**Address:** 333 Burma Road**City:** Oakland, CA 94607**Report No:** WIR-019182**Date Inspected:** 10-Jan-2011**Project Name:** SAS Superstructure**OSM Arrival Time:** 700**Prime Contractor:** American Bridge/Fluor Enterprises, a JV**OSM Departure Time:** 1900**Contractor:** Zhenhua Port Machinery Company, Ltd (ZPMC), Changxing Island **Location:** Shanghai, China**CWI Name:** Liu Hua Jie**CWI Present:** Yes No**Inspected CWI report:** Yes No N/A**Rod Oven in Use:** Yes No N/A**Electrode to specification:** Yes No N/A**Weld Procedures Followed:** Yes No N/A**Qualified Welders:** Yes No N/A**Verified Joint Fit-up:** Yes No N/A**Approved Drawings:** Yes No N/A**Approved WPS:** Yes No N/A**Delayed / Cancelled:** Yes No N/A**Bridge No:** 34-0006**Component:** OBG COMPONENT**Summary of Items Observed:**

WELDING INSPECTION REPORT

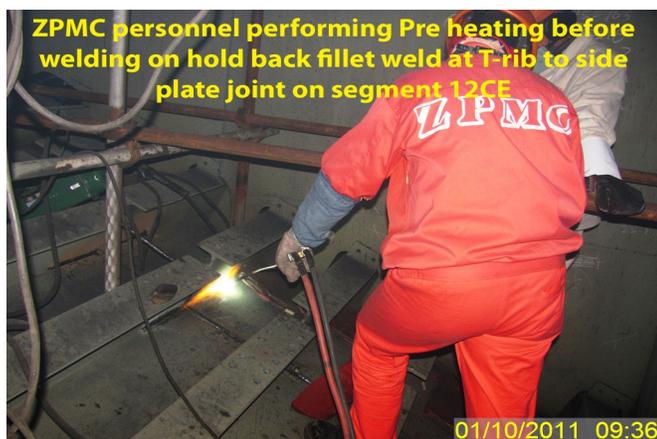
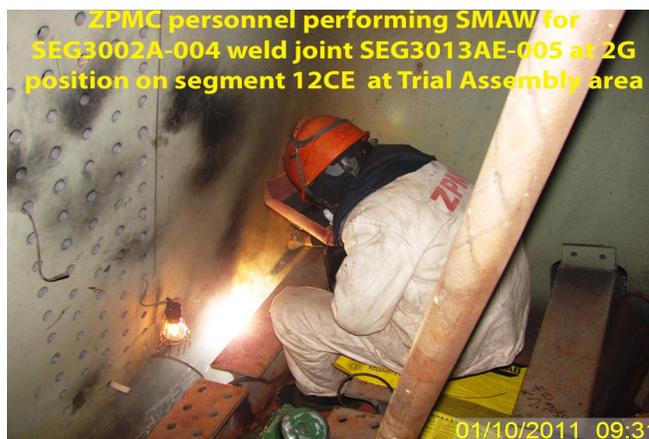
Unless otherwise noted, all work observed on this date appeared to generally comply with applicable contract documents.

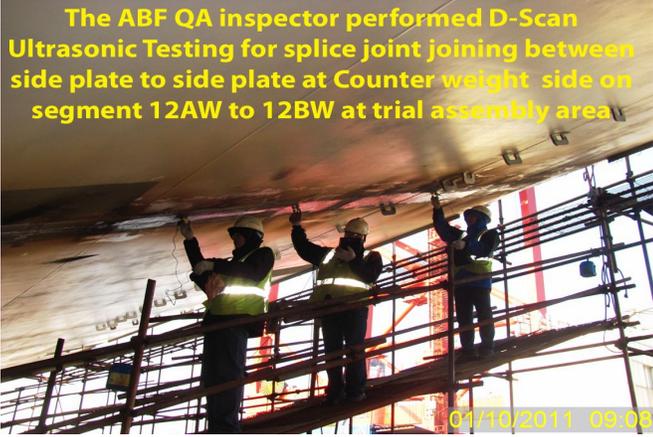
The ABF QA inspector performed D-Scan Ultrasonic Testing for splice joint joining between side plate to side plate at Counter weight side on segment 12AW to 12BW at trial assembly area
