DEPARTMENT OF TRANSPORTATION

Quality Assurance and Source Inspection

Contract #: 04-0120F4Cty: SF/ALA Rte: 80 PM: 13.2/13.9File #: 69.28**WELDING INSPECTION REPORT****Resident Engineer:** Siegenthaler, Peter**Address:** 333 Burma Road**City:** Oakland, CA 94607**Report No:** WIR-019201**Date Inspected:** 30-Dec-2010**Project Name:** SAS Superstructure**OSM Arrival Time:** 700**Prime Contractor:** American Bridge/Fluor Enterprises, a JV**OSM Departure Time:** 1900**Contractor:** Zhenhua Port Machinery Company, Ltd (ZPMC), Changxing Island **Location:** Shanghai, China**CWI Name:** Shi Lei**CWI Present:** Yes No**Inspected CWI report:** Yes No N/A**Rod Oven in Use:** Yes No N/A**Electrode to specification:** Yes No N/A**Weld Procedures Followed:** Yes No N/A**Qualified Welders:** Yes No N/A**Verified Joint Fit-up:** Yes No N/A**Approved Drawings:** Yes No N/A**Approved WPS:** Yes No N/A**Delayed / Cancelled:** Yes No N/A**Bridge No:** 34-0006**Component:** OBG Segments**Summary of Items Observed:**

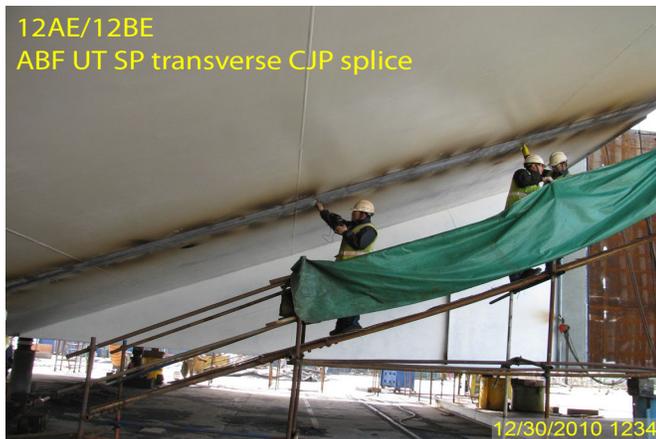
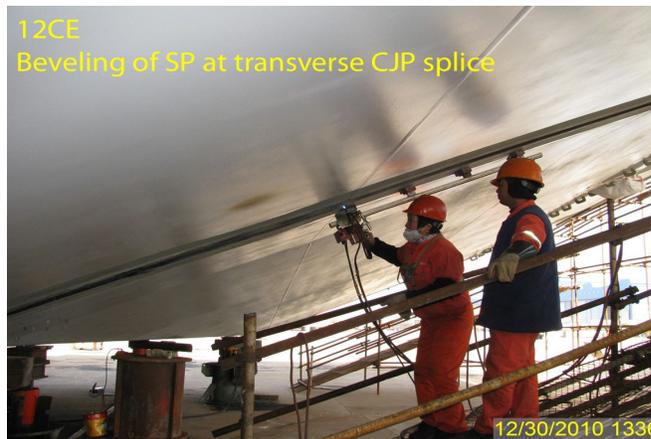
Unless otherwise noted, all work observed on this date appeared to generally comply with applicable contract documents.
